Avonmore Demonstration Catchment

Desk Study

June 2022

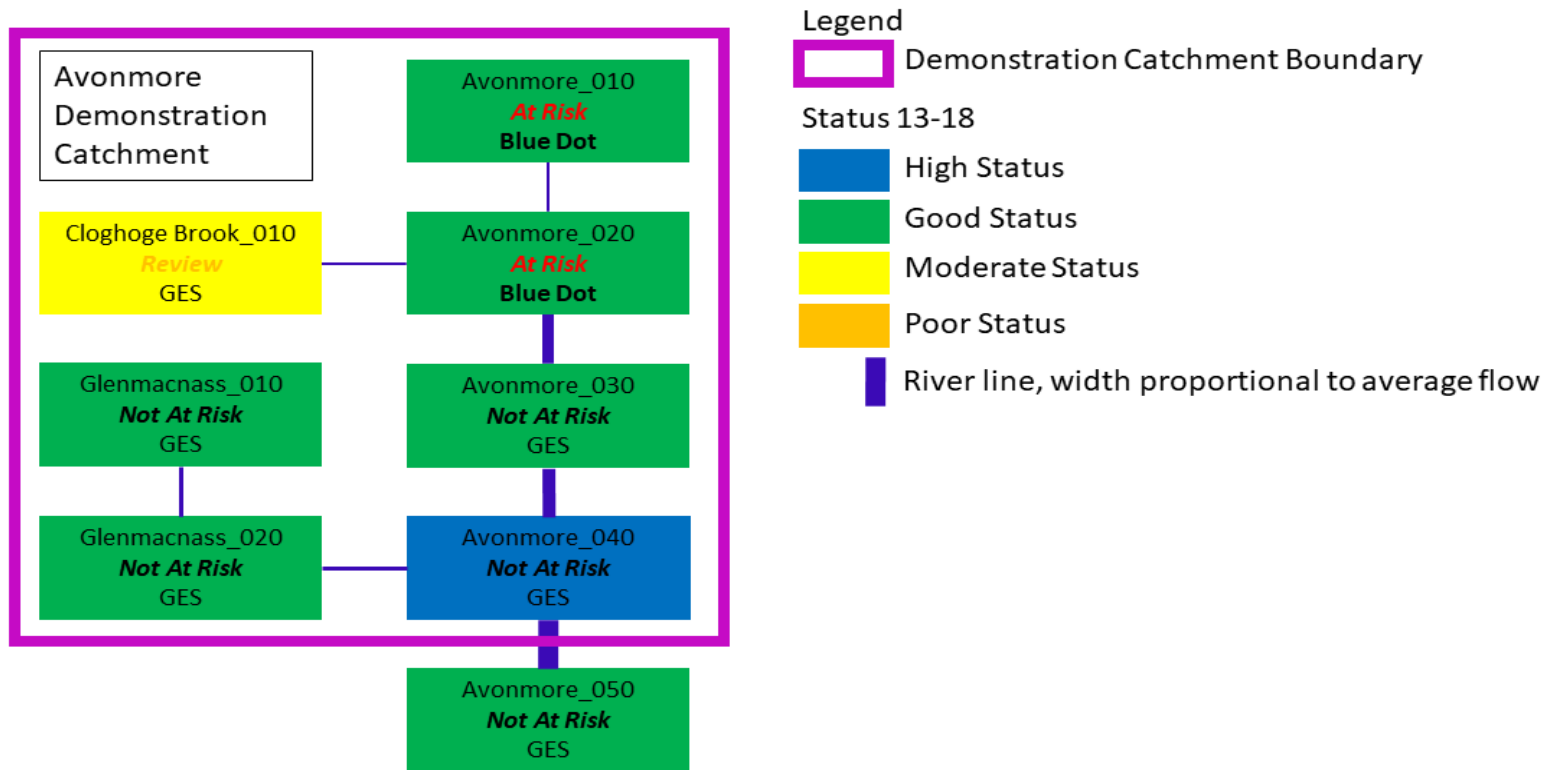
Figure 2 Schematic drawing of the Demonstration Catchment. Status of the river is represented by the colour.

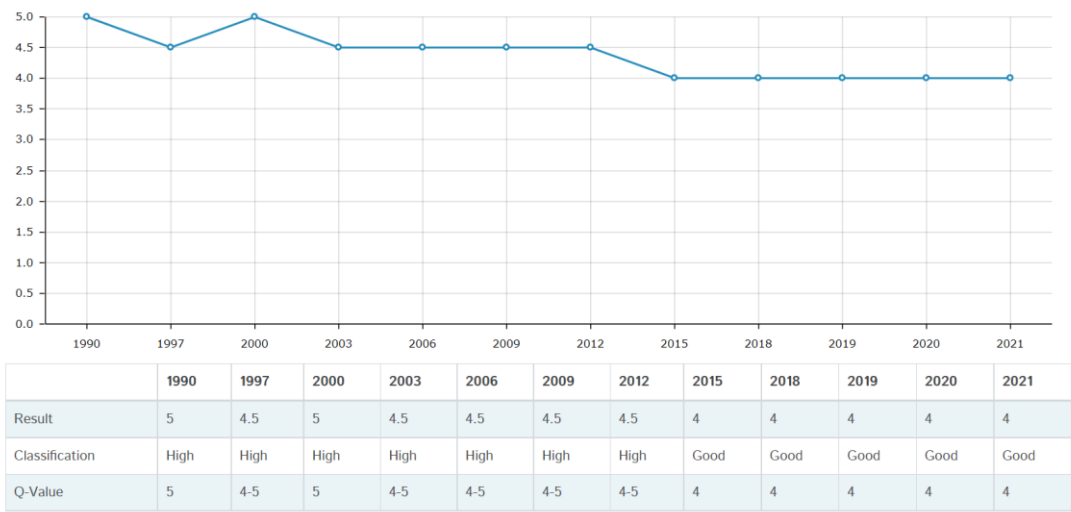
Figure 3 Q-Value chart and values for Avonmore_010 - Br d/s Lough Tay monitoring location.

- Avonmore_010 is a blue dot waterbody that is currently failing biological conditions. Operational monitoring point is located c. 1 km downstream of the outlet of Lough Tay. High biological conditions declined to Good and remained at Good since 2015 assessment (**Figure 3**). High biological conditions (Q5) have been recorded upstream of the lake.
- There is no exceedance of EQS for any nutrient. A single spike of ammonia was recorded in August 2021. Slight siltation was recorded at most recent EPA assessment.
- Acidification conditions failed during 2012-2014 (pH <4.5), causing decline to moderate ecological status 2010-2015. No failure of pH conditions was recorded since 2015, however, pH readings are low in the waterbody.

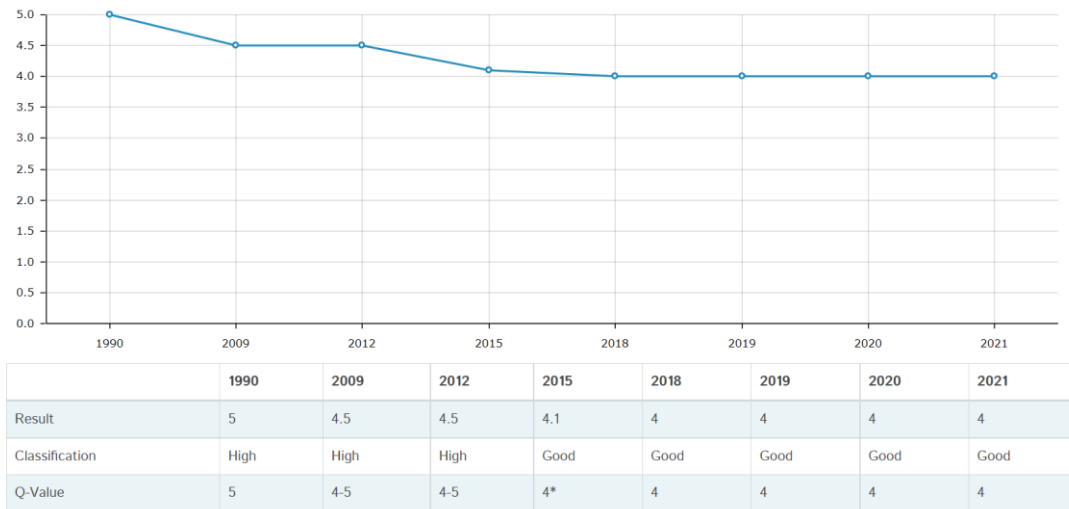
Figure 4 Q-Value chart and values for AVONMORE - Old Br monitoring location in Avonmore_020.¹

- Avonmore_020 is a blue dot waterbody that is currently failing biological conditions. Operational monitoring point is located c. 0.6 km downstream of the outlet of Lough Dan. High biological conditions declined to Good and remained at Good since 2015 assessment (**Figure 4**). Siltation (noted by Q-value asterisk) was marked at the 2015 assessment. Moderate siltation has been noted in most recent (2020) assessment.

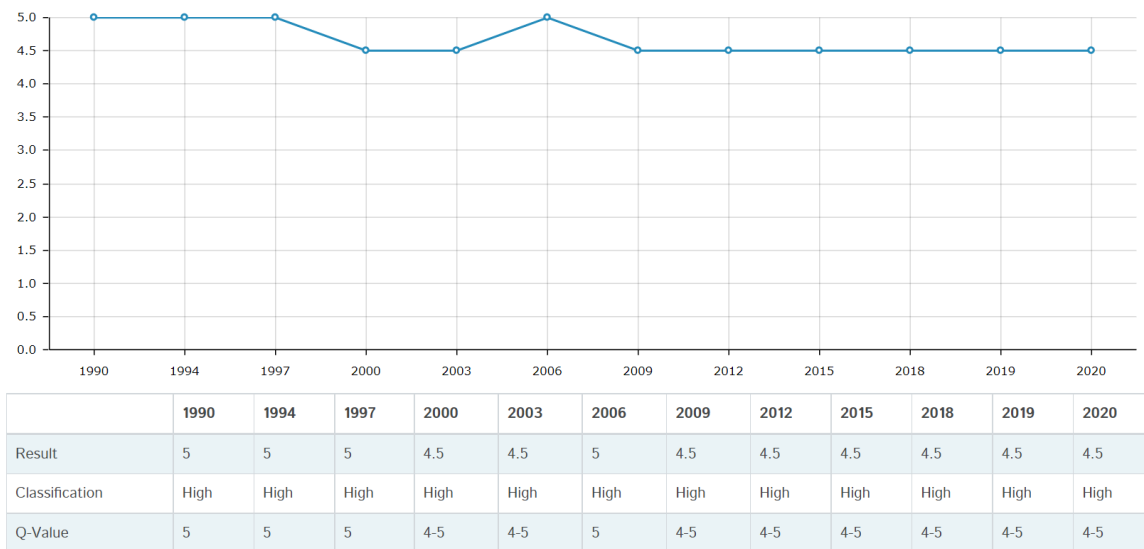
Figure 5 Q-Value chart and values for Cloghoge Brook_010 at Br u/s Annamoe R confl monitoring location.

- Cloghoge Brook_010 historically has been always at High biological status (**Figure 5**). However, it was not identified as a blue dot waterbody as ecological status has been always Moderate (through all WFD assessment cycles) due to failing acidification conditions.
- pH values are low, however no failure of 4.5 WFD threshold was recorded since 2017 (lowest pH of 4.6, see **Table 3**). There is however still a risk of future pH failures.

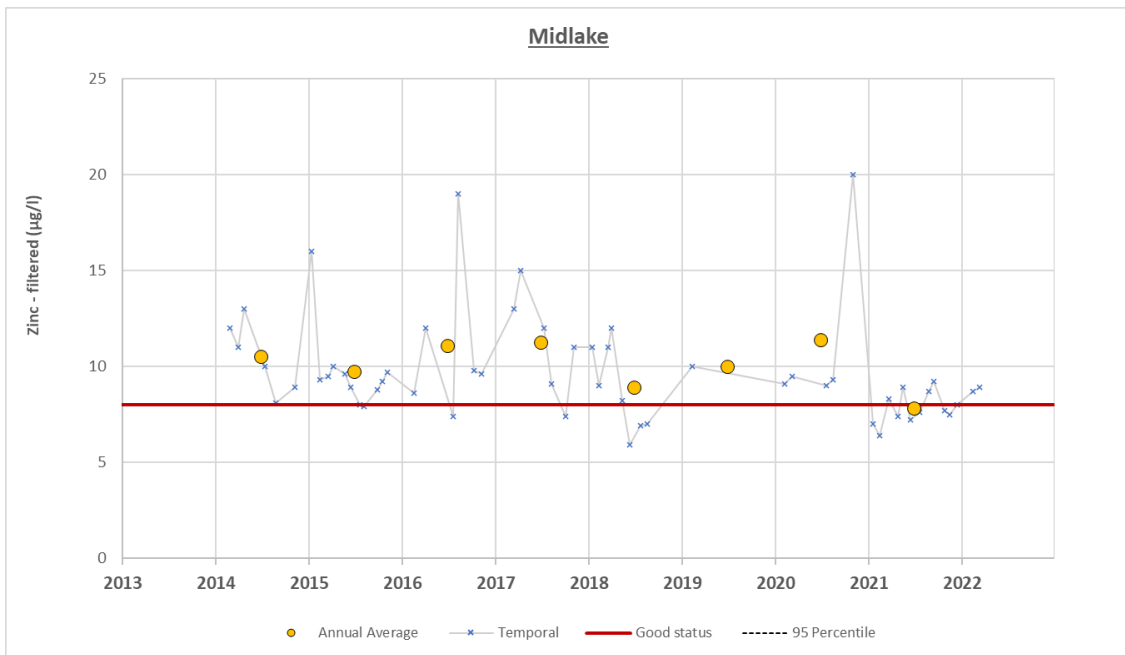
Figure 6 Temporal variations with annual mean concentration for zinc measured in Lough Tay at Midlake monitoring location.

Failure of specific pollutant conditions for ecological status is associated with higher concentrations of zinc in the lakes. Toxicity of zinc is related to its bioavailability which is dependent on physico-chemical parameters, such as pH (affecting metal solubility, and/or competing with zinc for absorption), hardness and the content of Dissolved Organic Carbon (DOC). DOC can bind zinc into non-labile form. Calcium content (but also H⁺) can compete with metals affecting its bioavailability at the biological receptors (Maycock, 2010).

It is assumed that zinc may originate from underlying geology in the catchment (although WFD Impact Assessment notes small lead and copper mine north of Lough Dan). In both lakes, the annual average concentrations fail the EQS of less or equal to 8ug/l (annual mean) for low hardness waters (< 10 mg/l CaCO₃) (Figure 6 - Figure 8). 2019-2021 baseline alkalinity (as CaCO₃) for Lough Tay (Midlake location) is 3.1 mg/l, and alkalinity for Lough Dan is 2.7 g/l for Site 1 and 2.8 mg/l or Site 2.

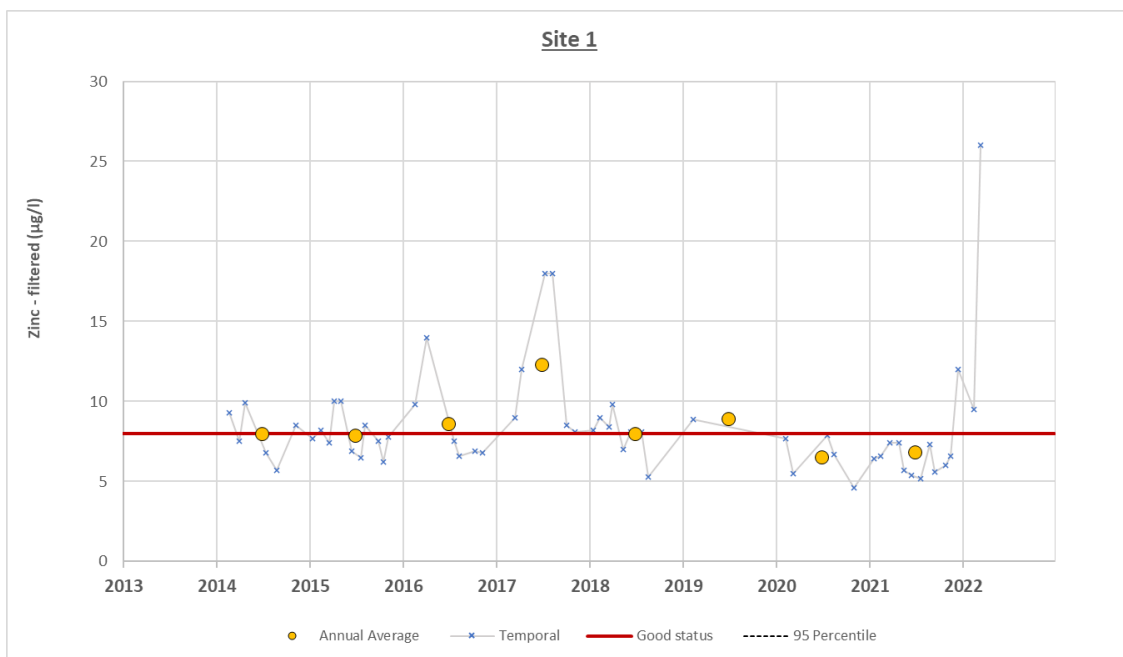
Figure 7 Temporal variations with annual mean concentration for zinc measured in Lough Dan at Site 1 monitoring location.

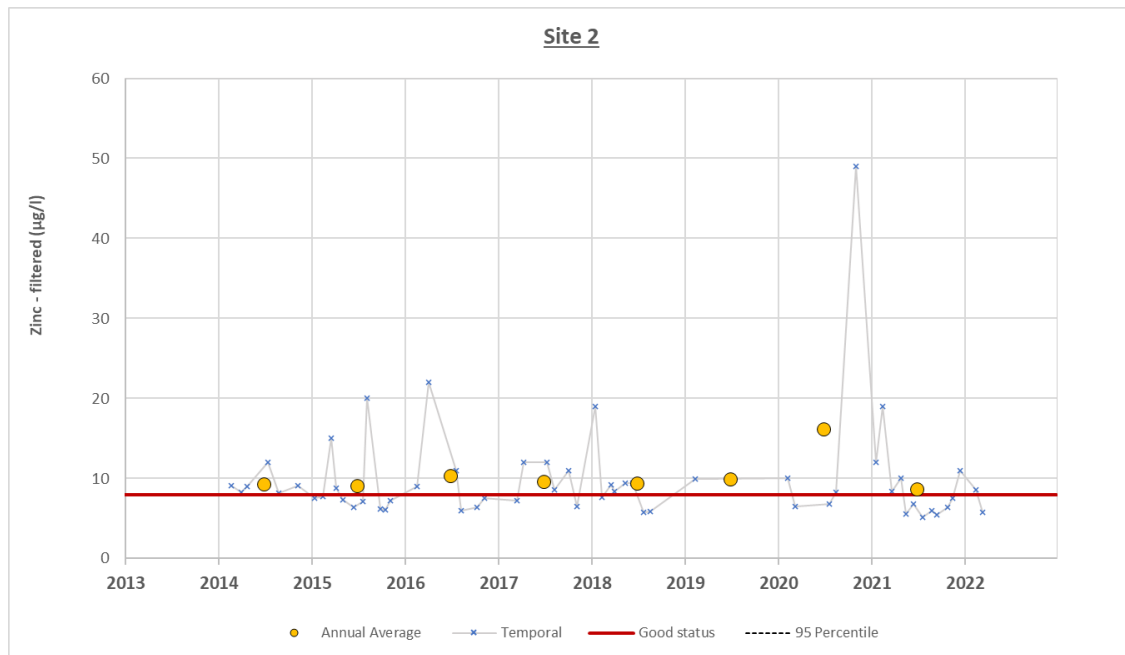
Figure 8 Temporal variations with annual mean concentration for zinc measured in Lough Dan at Site 2 monitoring location.

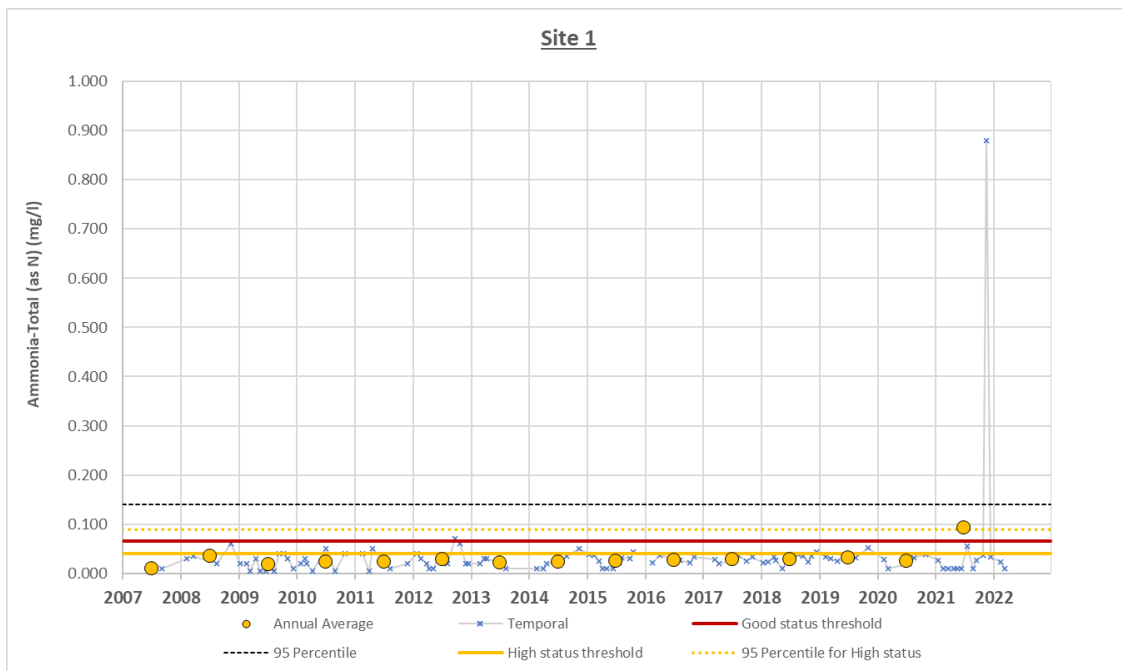
Figure 9 Total ammonia concentrations at Site 1, Lough Dan.

Note that total ammonia EQSs are the same for rivers and lakes. None of the annual mean ammonia concentrations exceeded the Good status annual mean EQS except for Site 1 at Lough Dan, which was caused by a single very high concentration of 0.88 mg/l as N recorded on 17/11/2021, **Figure 9**. River

water chemistry is collected on a different schedule therefore there is no corresponding chemistry sampling for the rivers on this date. While very high value was recorded at Site 1, no exceedance was found at Site 2 of Lough Dan suggesting possibly wastewater discharge close to Site 1 location.

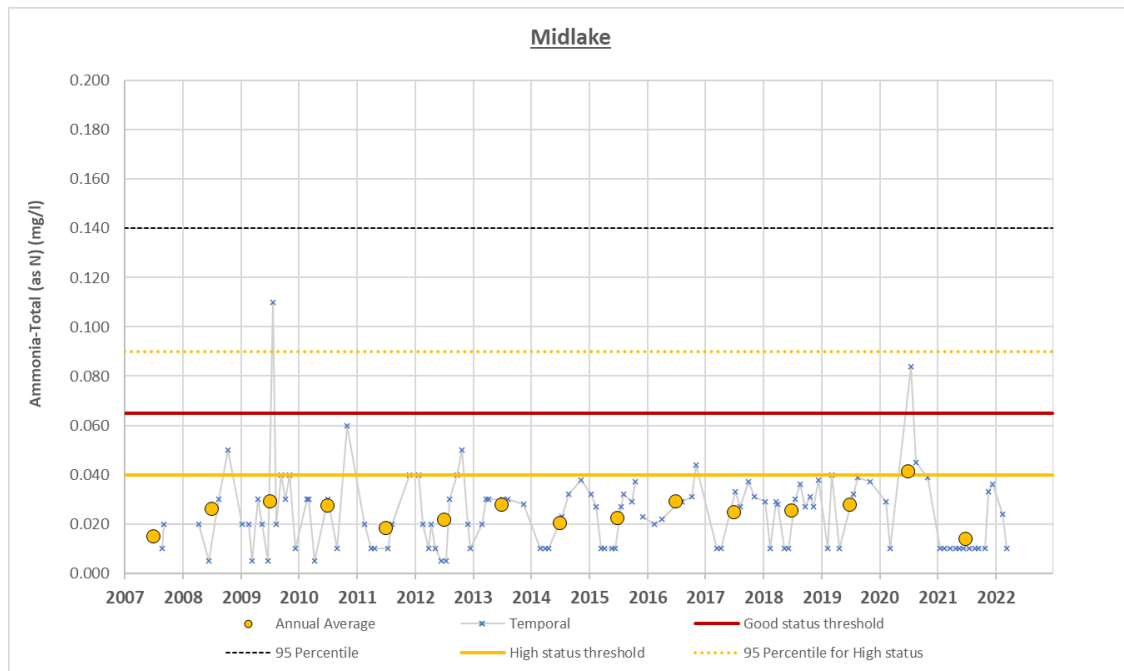
Figure 10 Total ammonia concentrations at Midlake, Lough Tay.

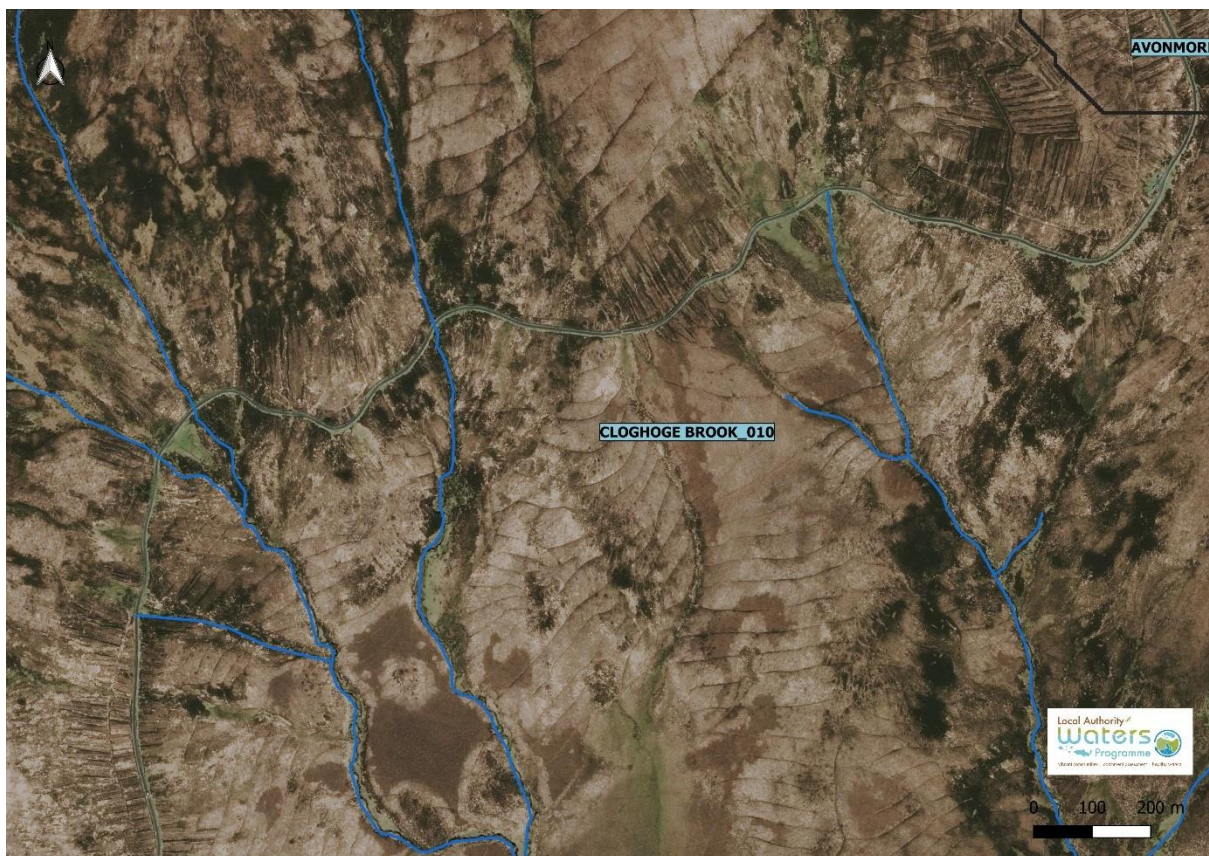
Figure 13 Peat extraction along the Military Road in Cloghoge Brook_010, © Ordnance Survey Ireland.

Historic peat extraction is mainly noted in the upper parts of this waterbody, along the Military Road (**Figure 13**). National Parks and Wildlife Service (NPWS) peat restoration works are currently under way in another waterbody in Wicklow Mountains (Liffey_010) that is having acidification issue. Impacts of this work on pH regimes is being monitored by LAWPRO and NPWS through pH review project. Learnings from this work could be applicable to the understanding of the issue in Cloghoge Brook_010.

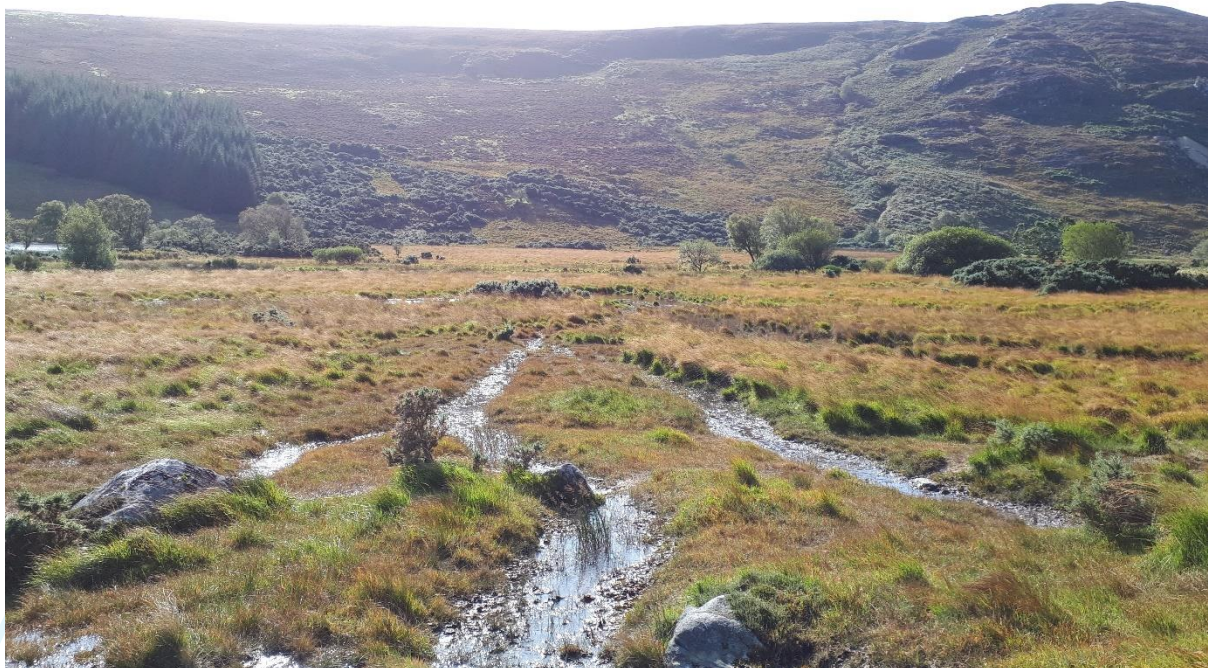
Figure 14 Connectivity pathways observed during catchment walk in the area north east to the Lough Dan.

The steep topography of Wicklow Mountains adds to hydrological connectivity of the headwaters of the sub-catchment. During LAWPRO catchment walks wet ground and water seeping through the ground to form overland flow directly connected to the stream network was evident (**Figure 14** Error! Reference source not found.-**Figure 16**).

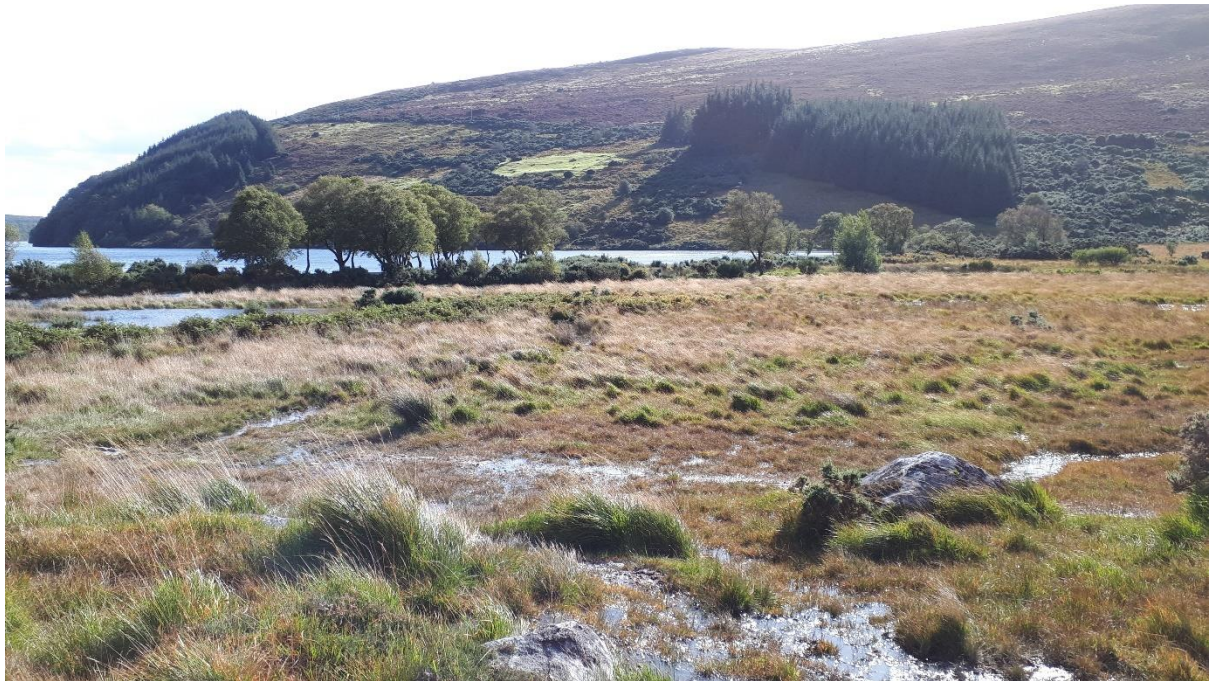
Figure 15 Connectivity pathways observed during catchment walk in the area. View of the Lough Dan.

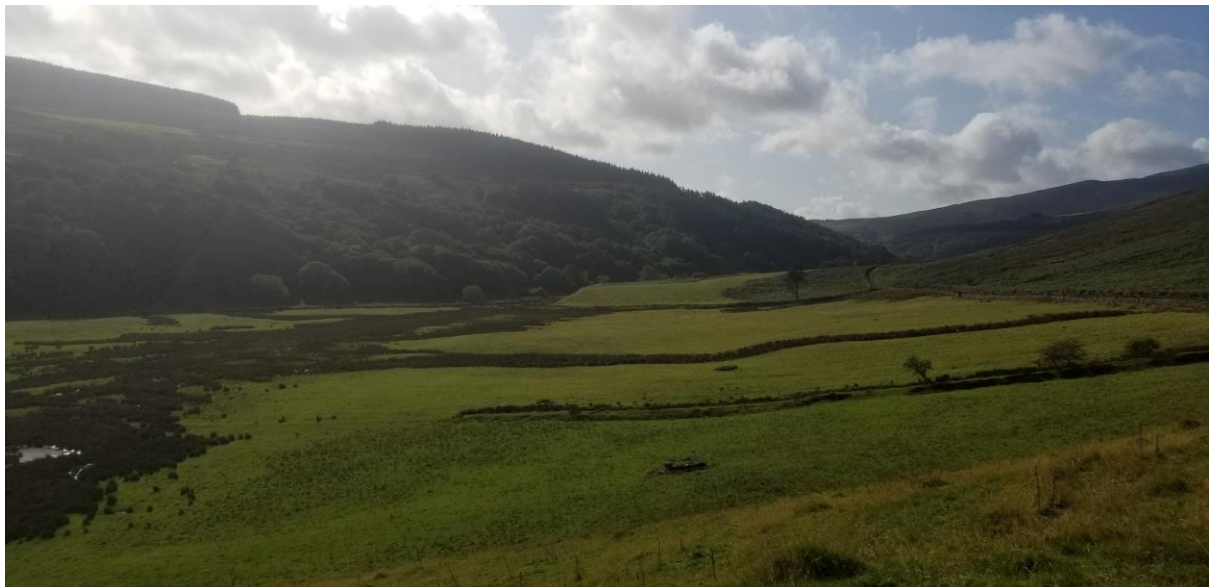
Figure 16 View of Cloghoge River in Avonmore_020, between Avonmore_010 and Lough Dan. Darker vegetation shows more wetland conditions along the river and along the runoff pathways from the mountains into the river.

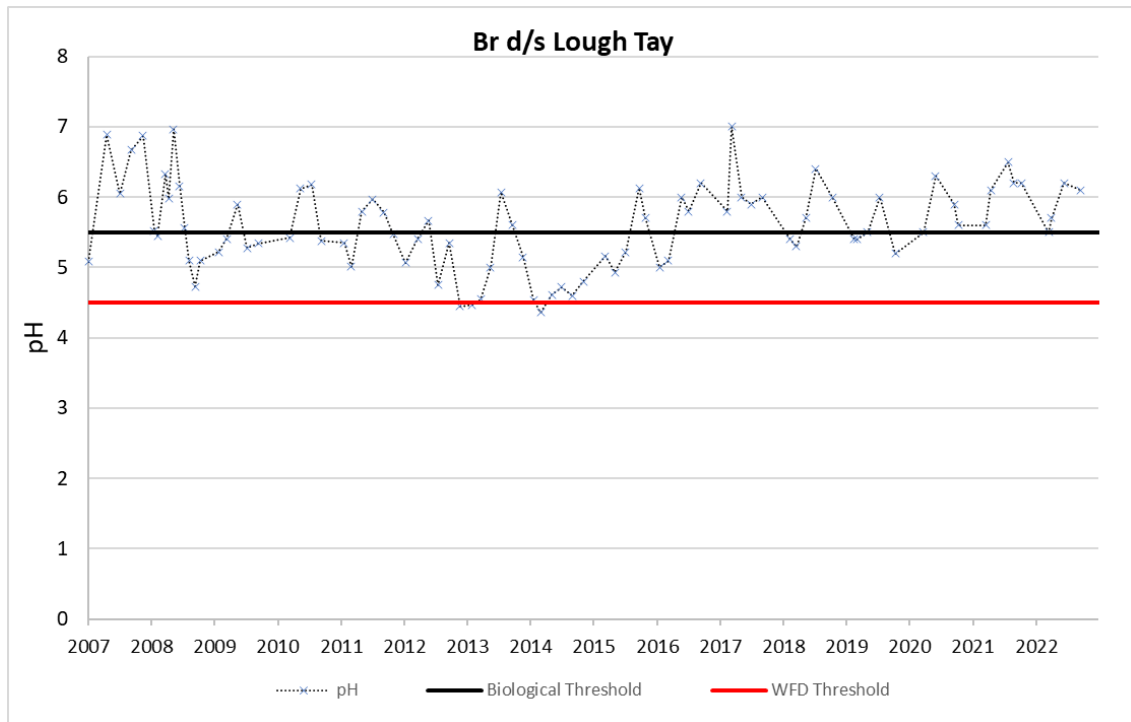
Figure 17 Temporal variations in pH values recorded in Avonmore_010.

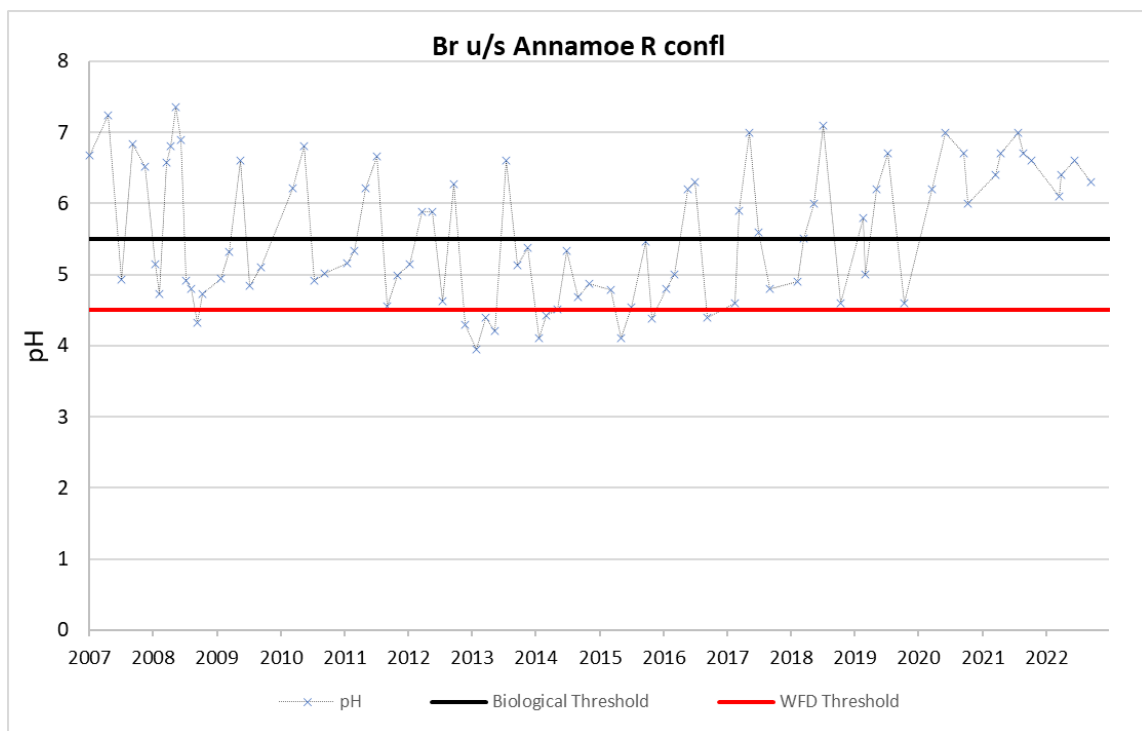
Figure 18 Temporal variations in pH values recorded in Cloghoge Brook_010.

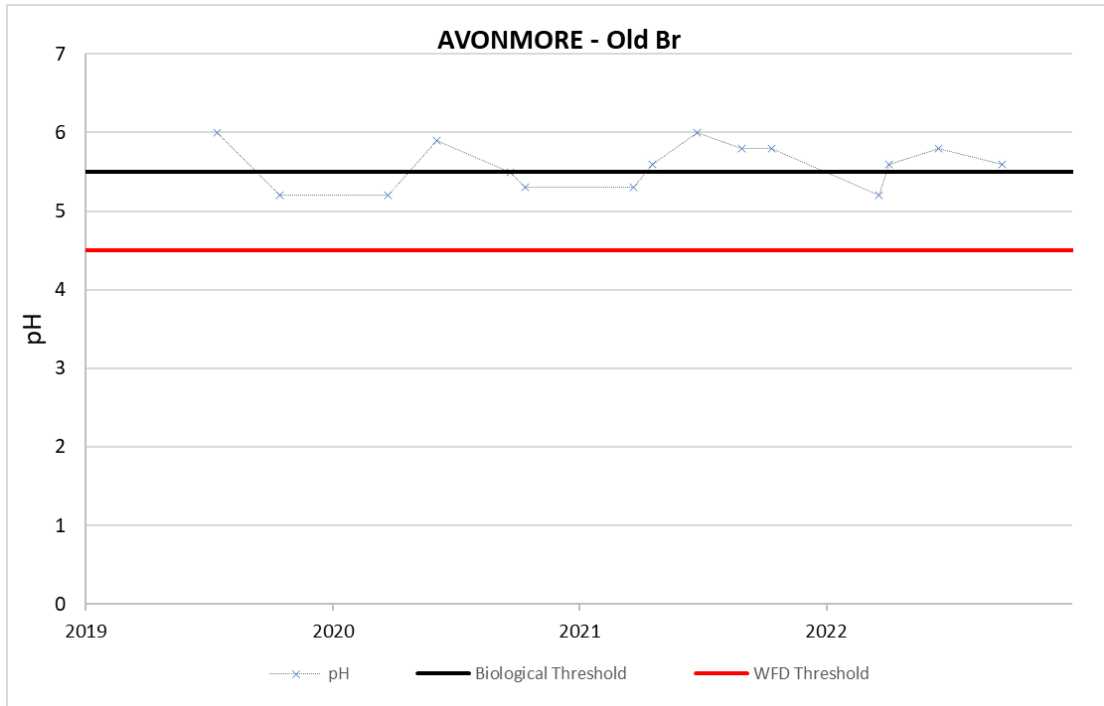
Figure 19 Temporal variations in pH values recorded in Avonmore_020.

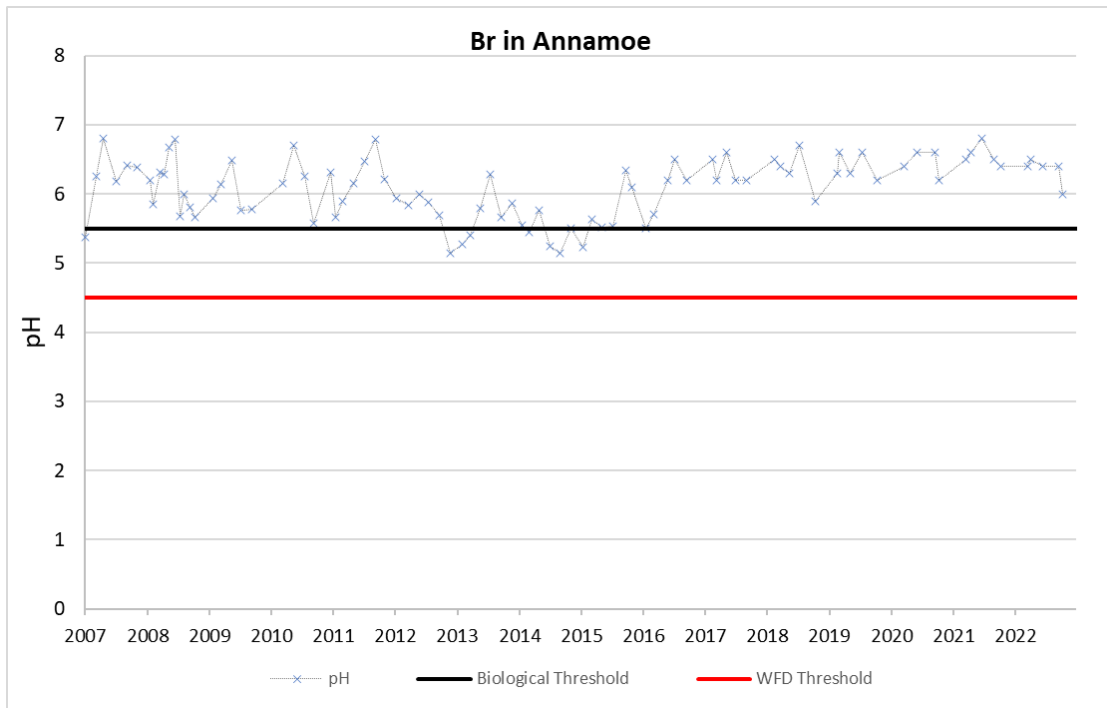
Figure 20 Temporal variations in pH values recorded in Avonmore_030.

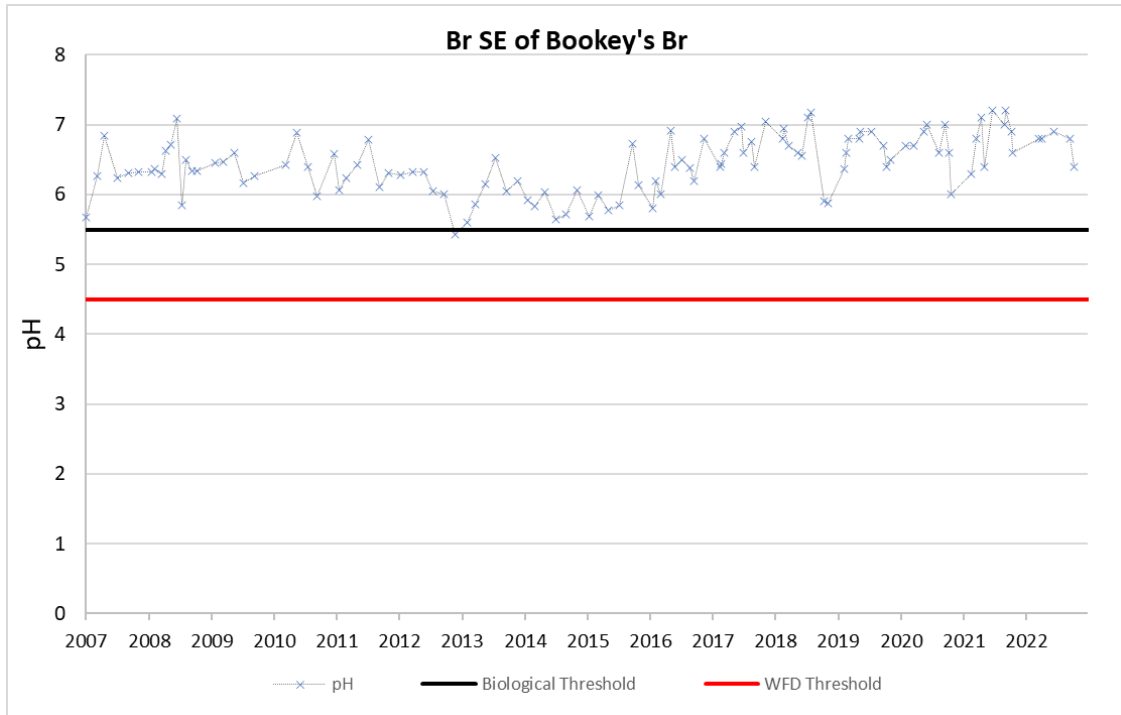
Figure 21 Temporal variations in pH values recorded in Avonmore_040.

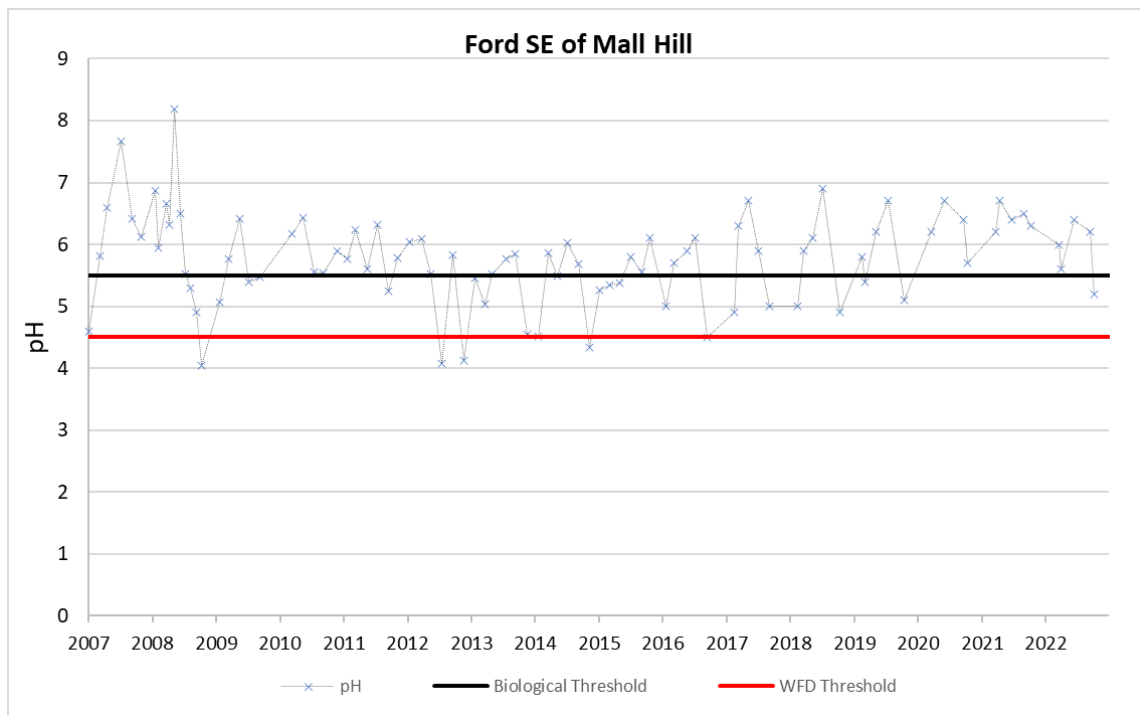
Figure 22 Temporal variations in pH values recorded in Glenmacnass_010.

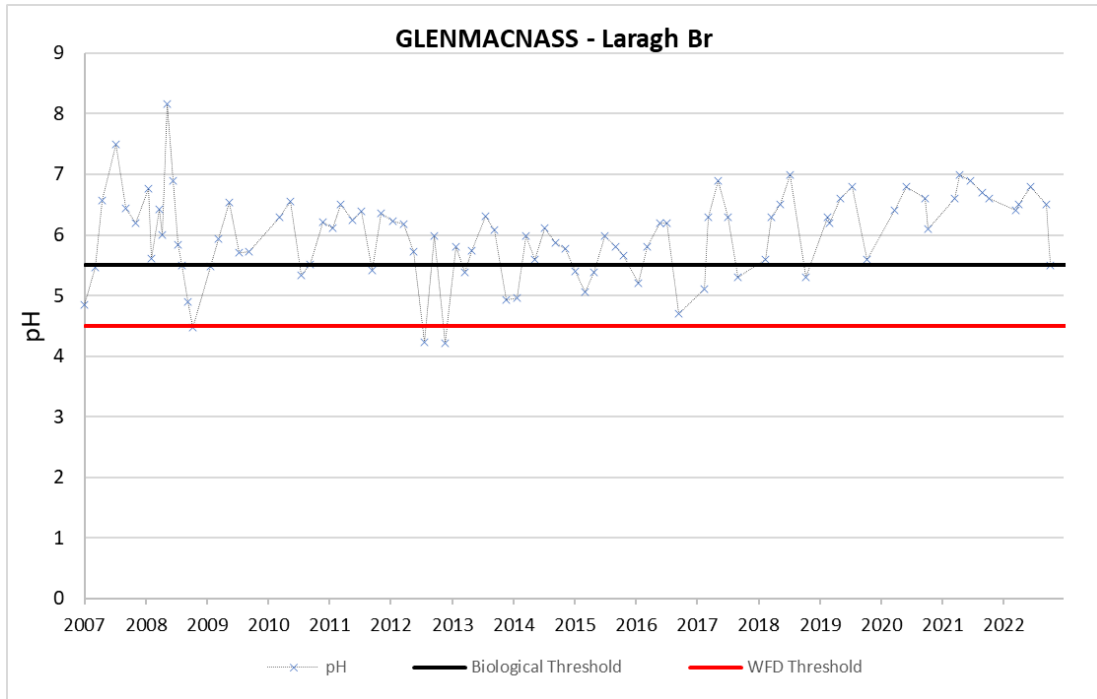
Figure 23 Temporal variations in pH values recorded in Glenmacnass_020 at Laragh Br monitoring location.

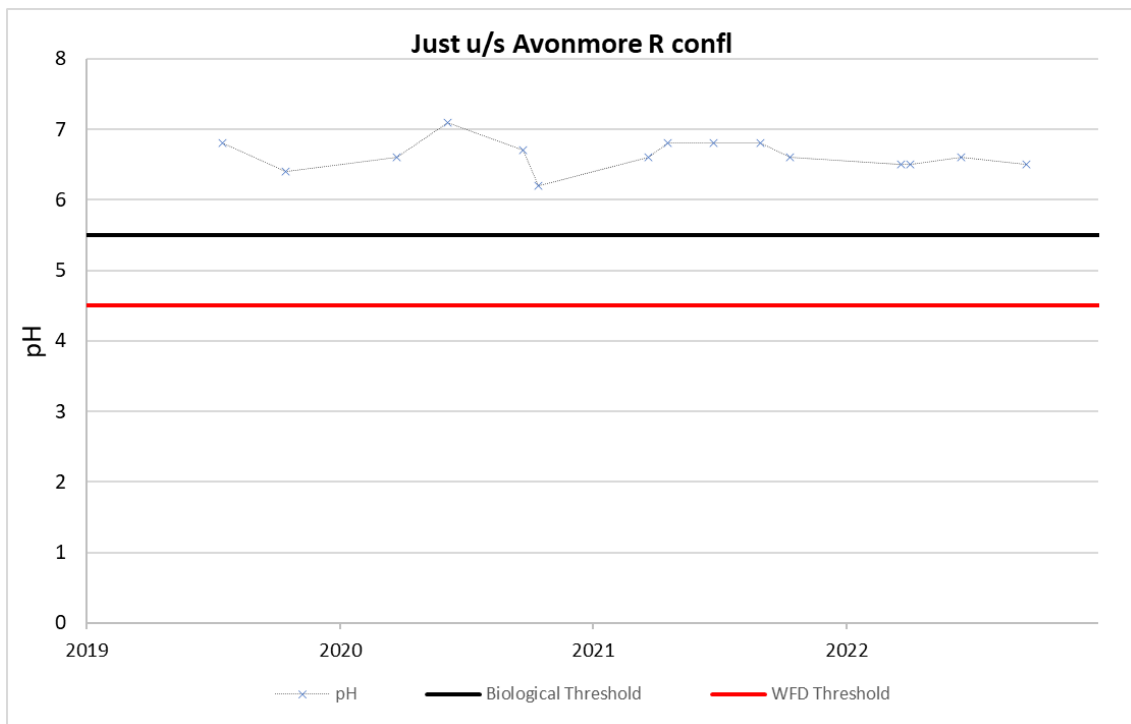
Figure 24 Temporal variations in pH values recorded in Glenmacnass_020 at 'Just u/s Avonmore R confl' monitoring station.

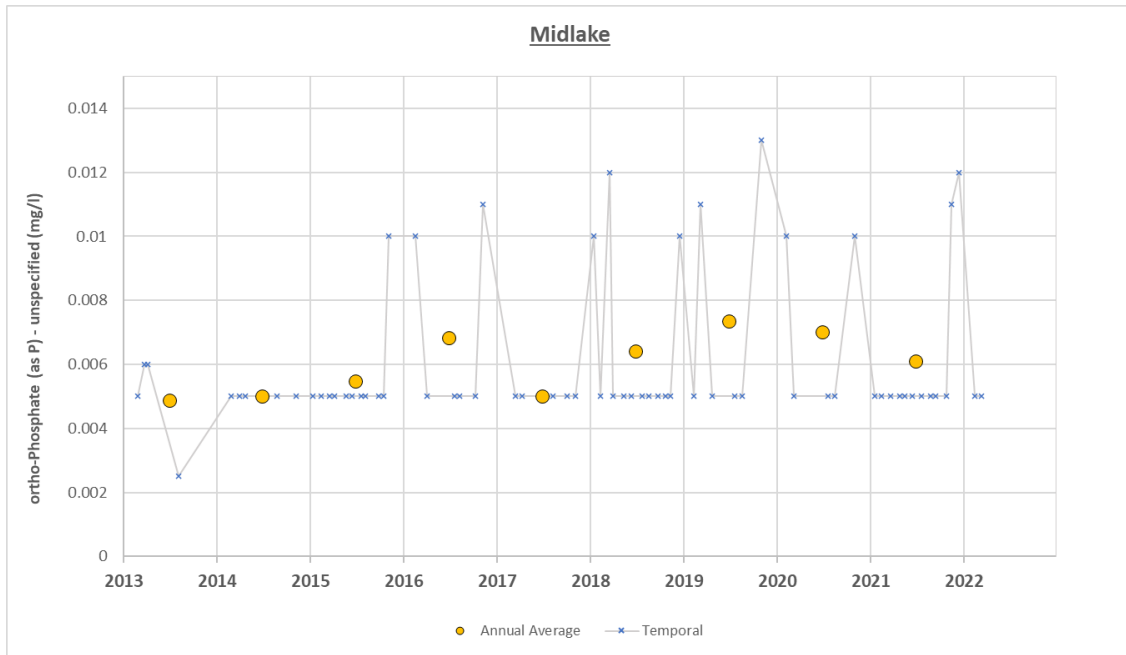
Figure 25 Ortho-phosphate concentrations at Lough Tay.

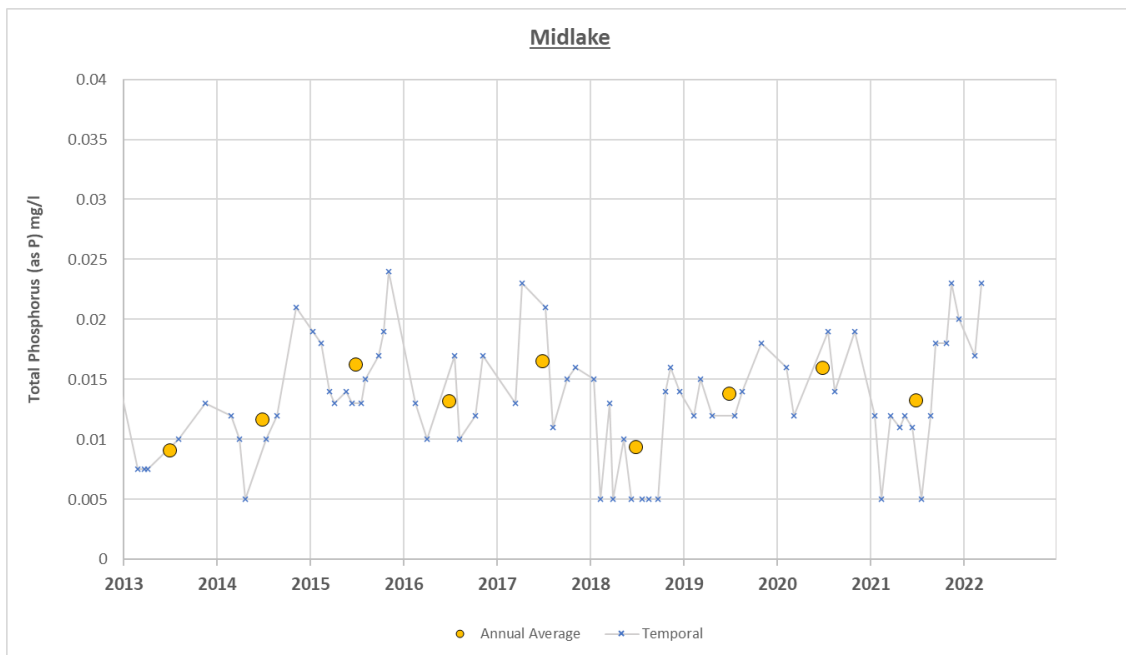
Figure 26 Total phosphorous concentrations at Lough Tay.

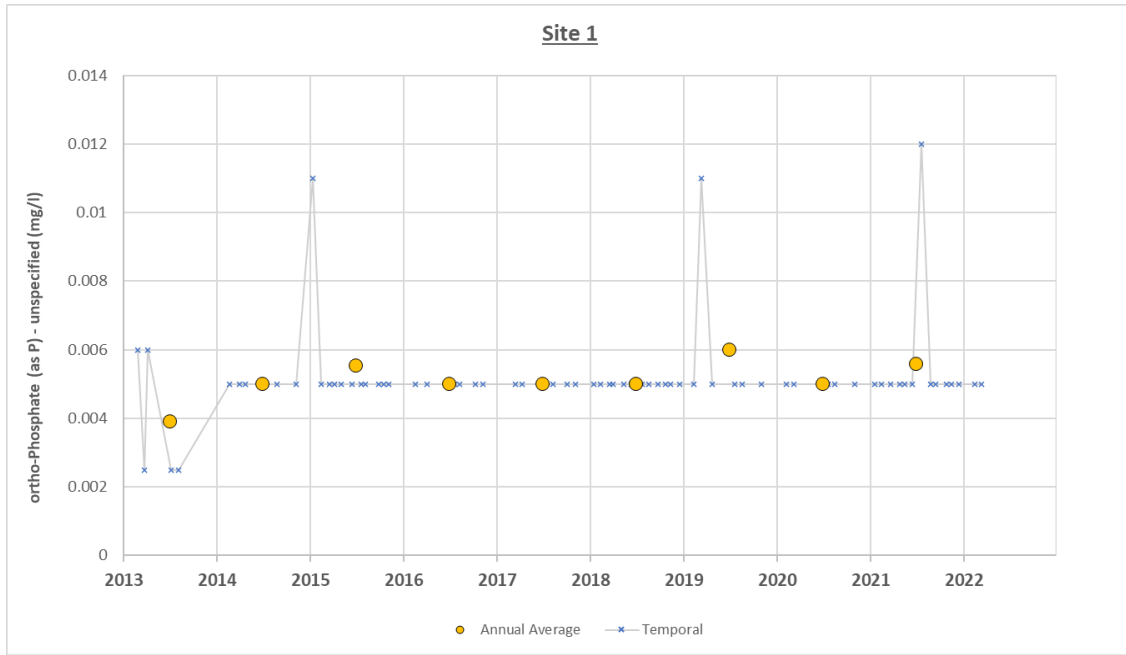
Figure 27 Ortho-phosphate concentrations at Site 1, Lough Dan.

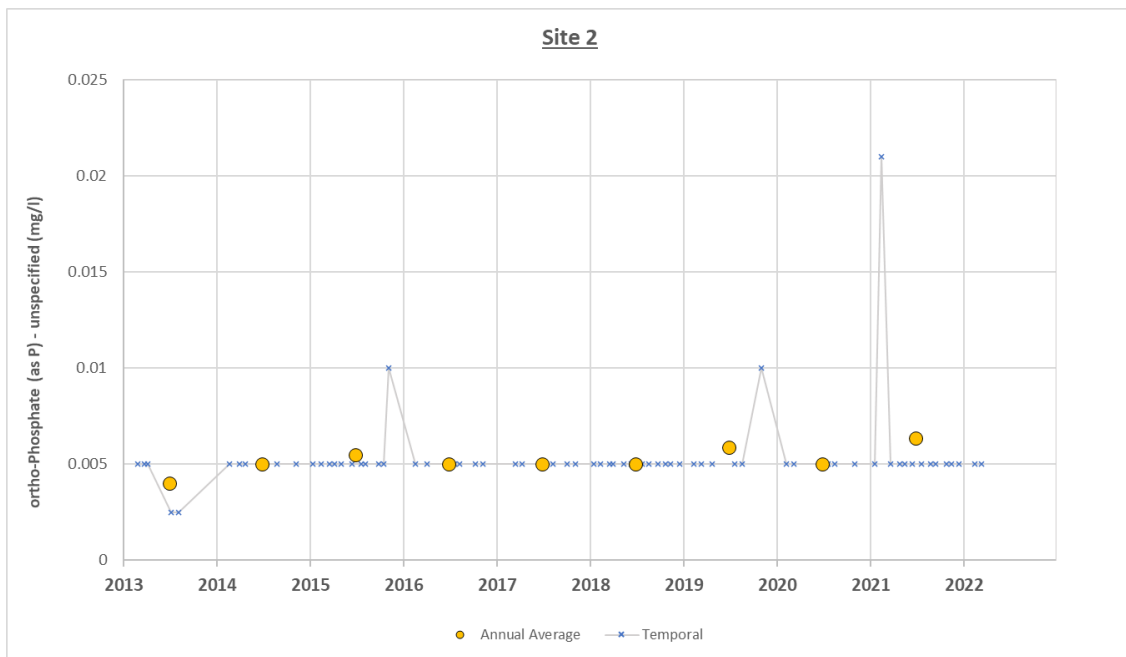
Figure 28 Ortho-phosphate concentrations at Site 2, Lough Dan.

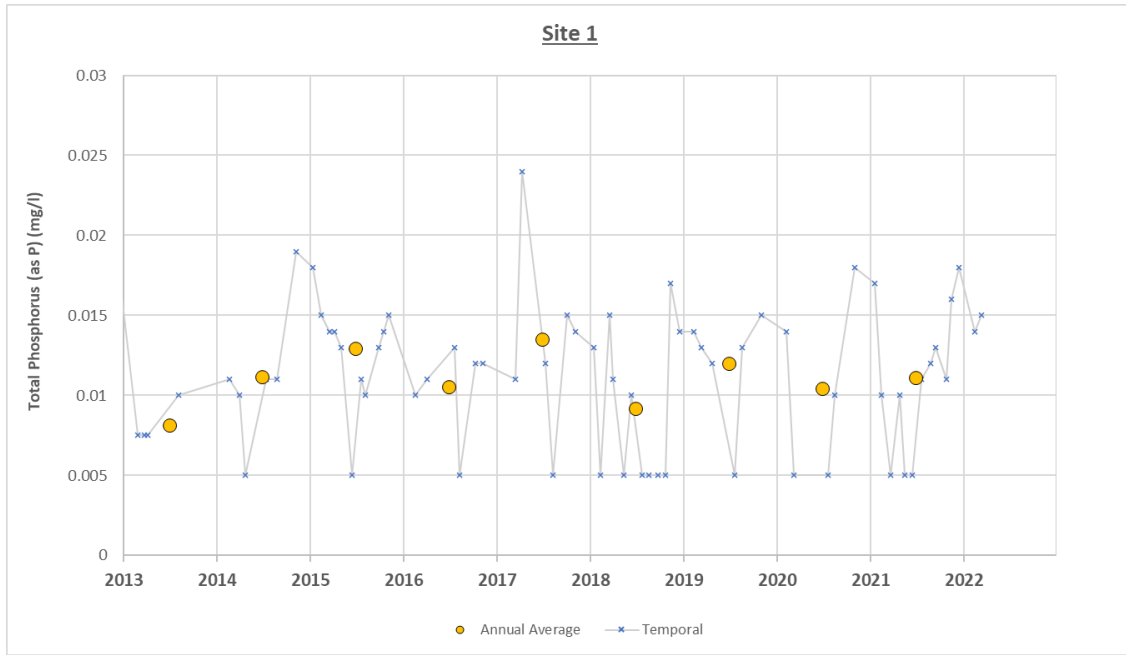
Figure 29 Total phosphorous concentrations at Site 1, Lough Dan.

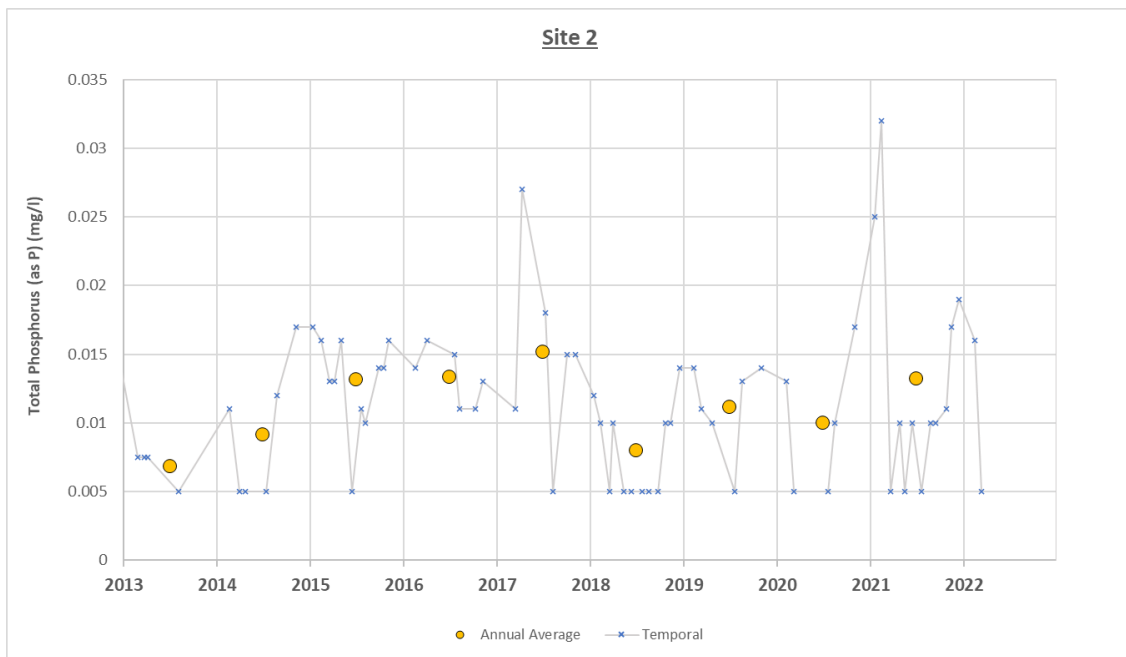
Figure 30 Total phosphorous concentrations at Site 2, Lough Dan.
