Sheen Control Catchment

Desk Study

April 2023

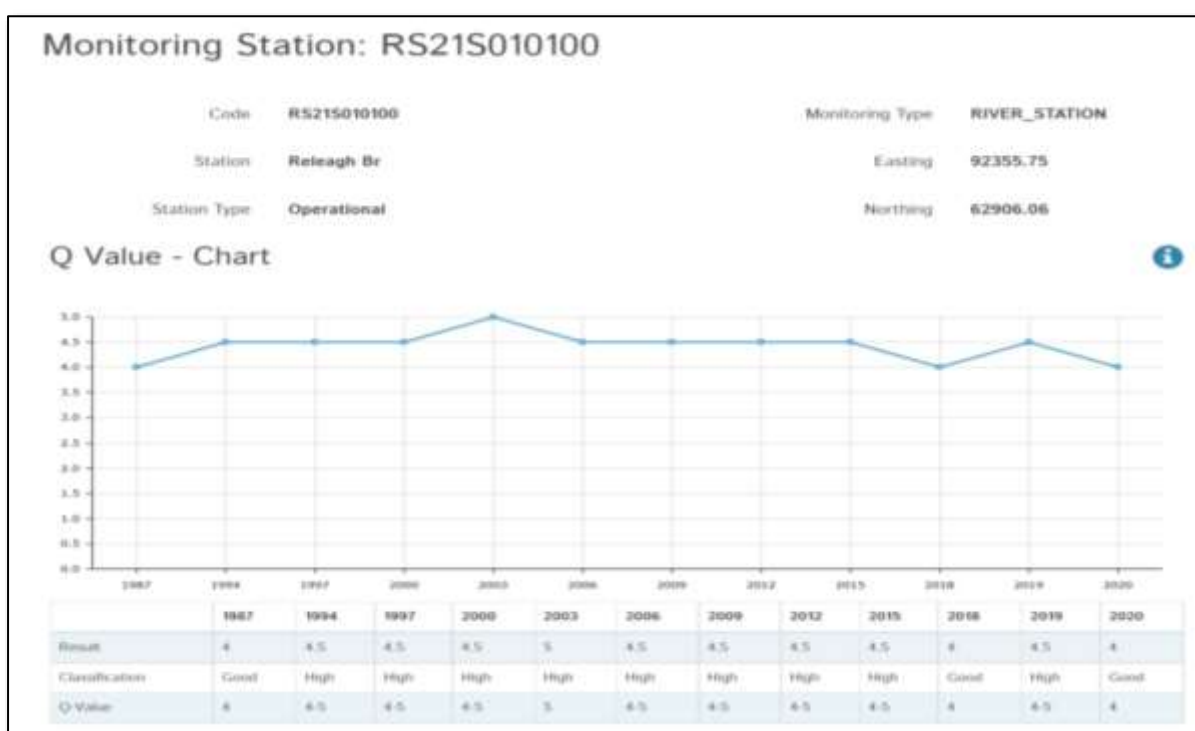
Figure 3: Biological monitoring at Releagh Br., outlet of Sheen_010

'Releagh Br' operational monitoring station (21S010100) is located at the outlet of Sheen_010 (refer to map Fig 2). **Figure 3** below shows the biological monitoring record for Releagh Br. The site saw a drop to Q4 in 2018 while prior to that, results had been consistently stable at Q4-5 since 1994 (Q5 in 2003). The site improved back to Q4-5 in 2019 but subsequently deteriorated again to Q4 in 2020.

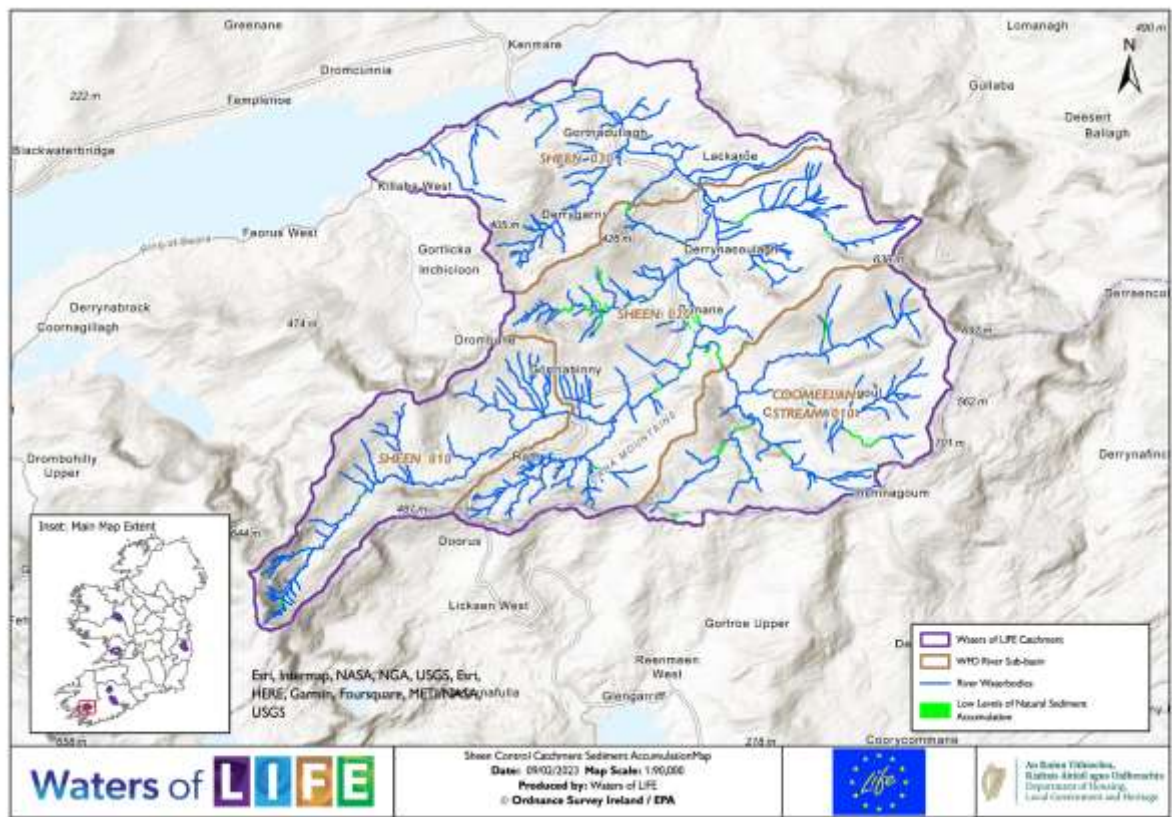
Figure 8: Natural sediment accumulation risk, Sheen control catchment

The substrate zoning for risk of natural sediment accumulation for the control catchment is shown in **Figure 7** below. The high to extensive areas are associated with peat and variable areas are mixed substrate/tills. However, the assessed risk of natural sediment accumulation in channels in the catchment all fall into the low category and confined to some smaller tributary streams (see **Figure 8**) mainly in Coomeelan Stream_010 and Sheen_020.

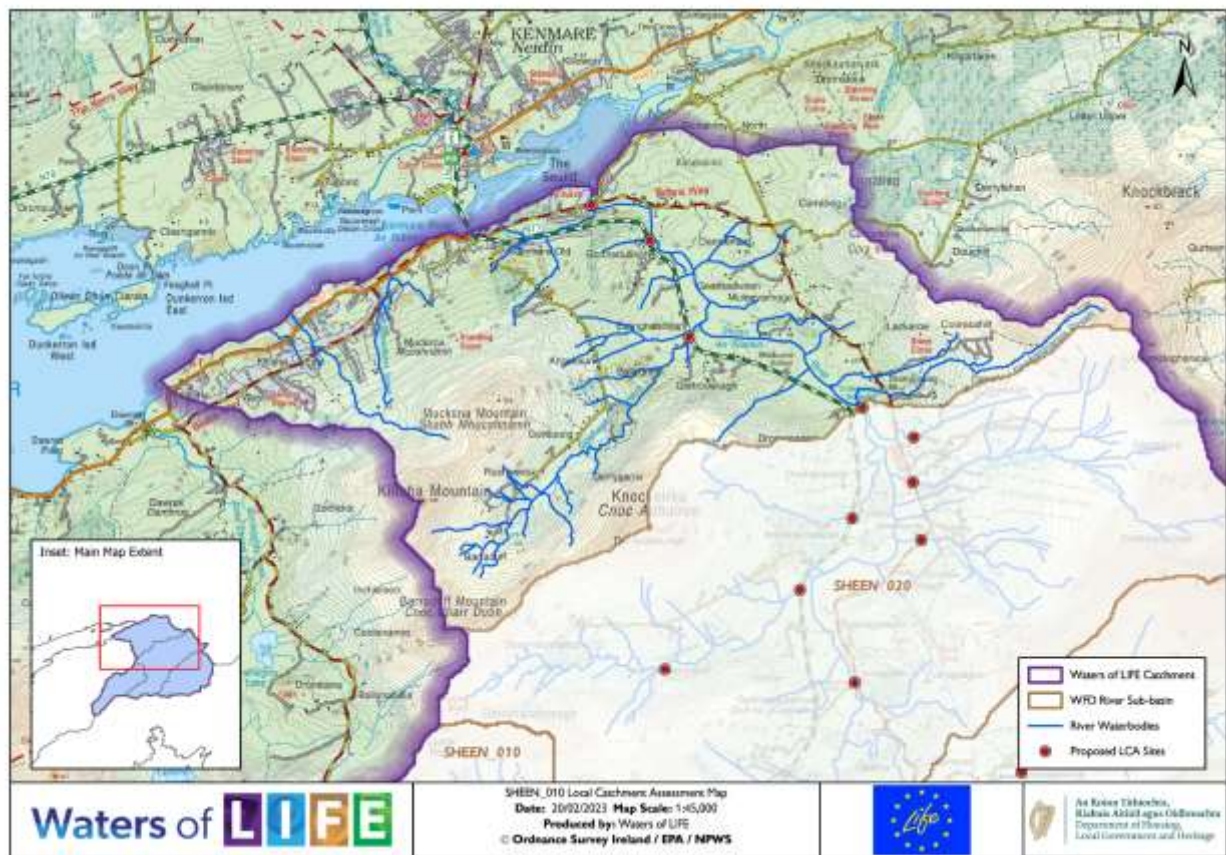
Figure 18: Initial LCA locations, Sheen_030
