Graney Demonstration Catchment

Desk Study

October 2022

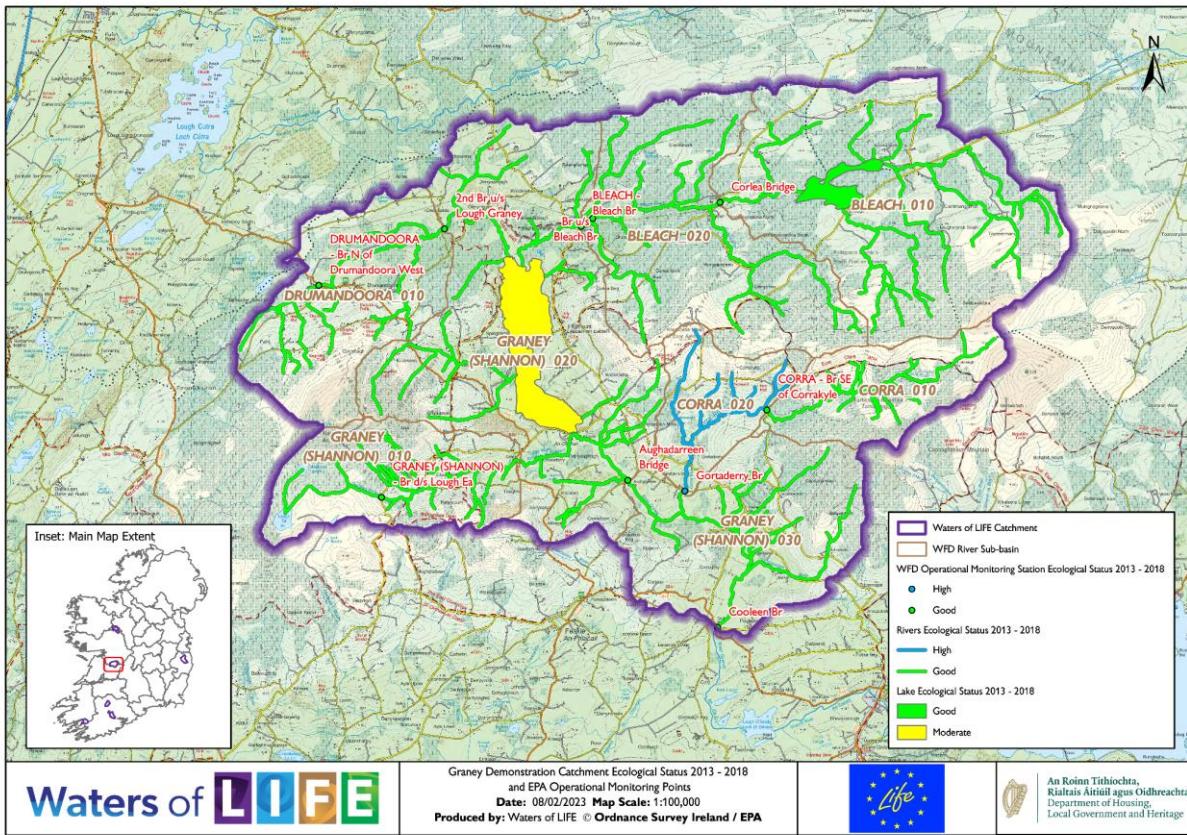
Figure 1 WFD status map, Graney Demonstration Catchment

Figure 1 and **Figure 2** show location of the Graney Demonstration Catchment, waterbodies within, the latest ecological status (2013-2018) and cycle 3 WFD risk. A schematic layout of the catchment is provided in **Figure 3**. Summary information on ecological status, risk, known pressures and associated significance for the waterbodies in the catchment is presented in **Table 1**. This is further summarised in the 'Receptor information and assessment' section.

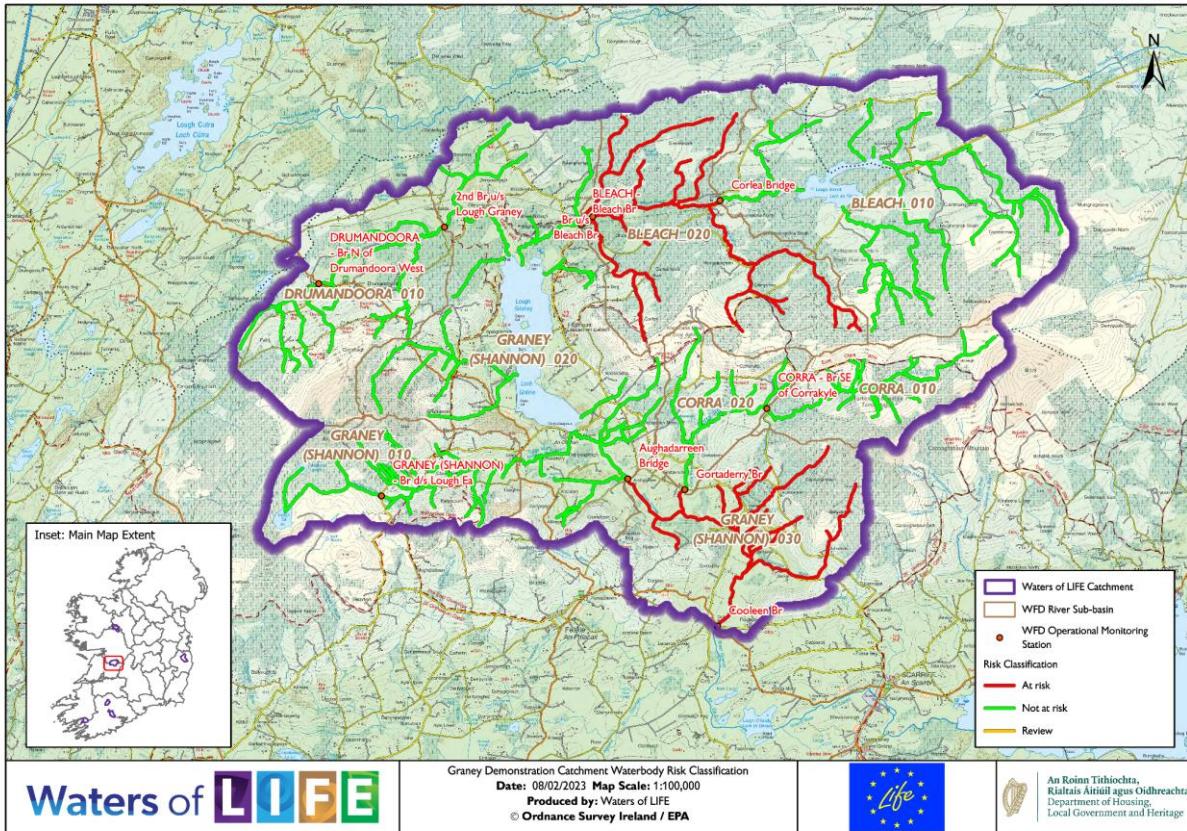
Figure 2 WFD risk map, cycle 3, Graney Demonstration Catchment

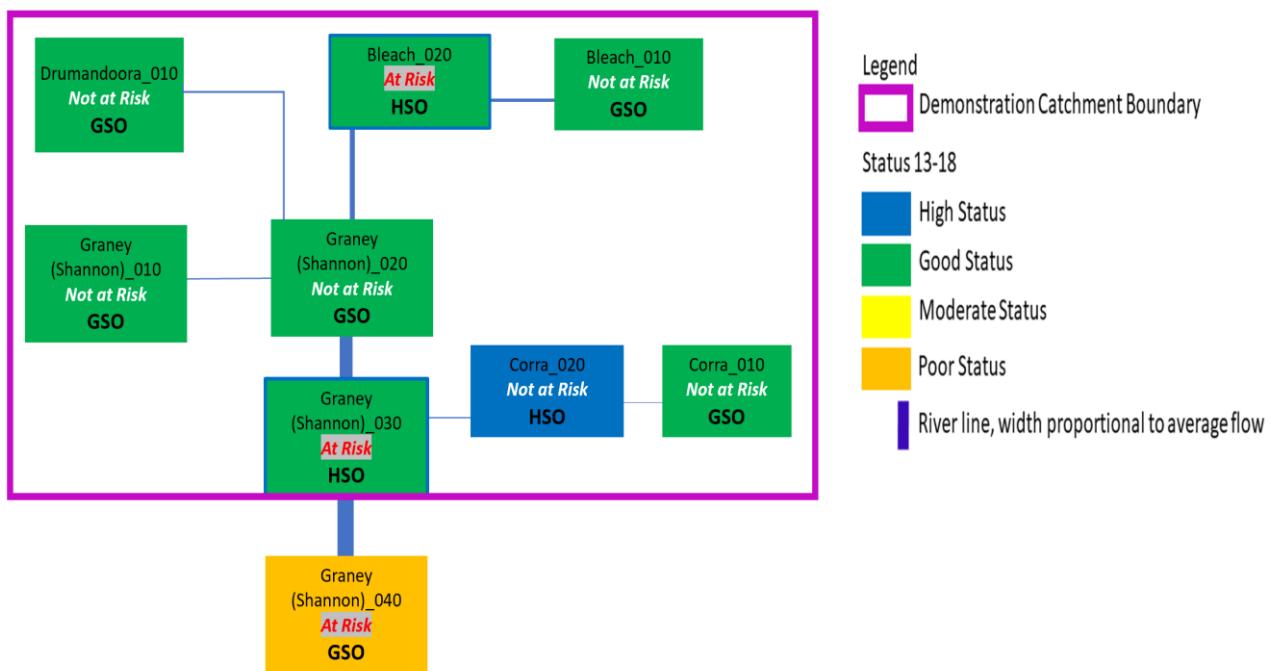
Note : 2013-2018 Ecological Status is shown here. Biological status dropped to Good at the Corra_020 WFD monitoring point and Moderate at the Graney (Shannon)_020 monitoring point in the EPA 2021 survey.

Figure 3 Schematic layout of the waterbodies in the Graney Demonstration Catchment

Note that shading indicates the 2013-2018 ecological status for each waterbody. Italicised text indicates Cycle 3 Risk

Situated mainly in north east County Clare, the Graney Demonstration Catchment comprises four rivers (eight river waterbodies) in subcatchment 25C_8 Graney [Shannon]_SC_020), the Bleach, Corra, Drumandoora and Graney (Shannon). The river Bleach (Bleach_010 and Bleach_020) rises in the north-east of the subcatchment in County Galway and flows west into Graney (Shannon)_020. Lough Atorick sits in the Bleach_010 sub-basin. Two rivers flow from the west of the subcatchment; Drumandoora_010 rises in the north-west, flowing east to join the Graney (Shannon)_020 and eventually discharging to Lough Graney. Graney (Shannon)_010 rises in the south-west and flows east into Graney (Shannon)_020 joining the Graney River south of Lough Graney. Lough Graney is located on Graney (Shannon)_020 which flows from north to south across the centre of the subcatchment into Graney (Shannon)_030. The River Corra (Corra_010 and Corra_020) rises in the south-east of the sub-catchment and flows into Graney (Shannon)_030. Graney (Shannon)_030 flows south into Graney (Shannon)_040, part of subcatchment 25C_3 Graney [Shannon] SC_010 and outside the demonstration catchment boundary (**Figure 3**).

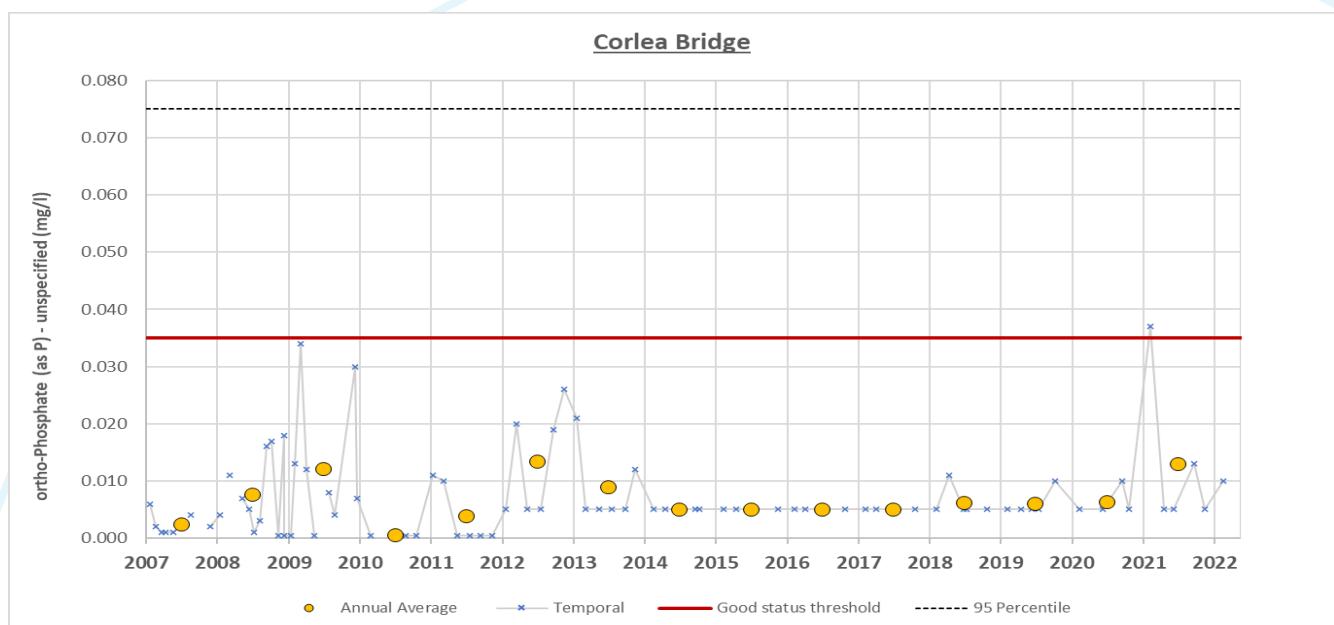
Figure 4 Orthophosphate concentrations at Corlea Bridge from Jan 2007 to Feb 2022

From WFD chemistry monitoring data available for Corlea Bridge, nutrients do not appear to be a cause for concern in Bleach_010. Annual average orthophosphate results were well below the mean Good status EQS of 0.035mg/l from 2007 to 2021 inclusive (**Figure 4**). Individual sample results were also consistently below the mean EQS within the exception of one result in February 2021 which marginally exceeded 0.035mg/l but was significantly below the 95%ile limit of 0.075mg/l. 85% of individual sample results between February 2014 and April 2022 have been below the orthophosphate detection limit of 0.01mg/l.

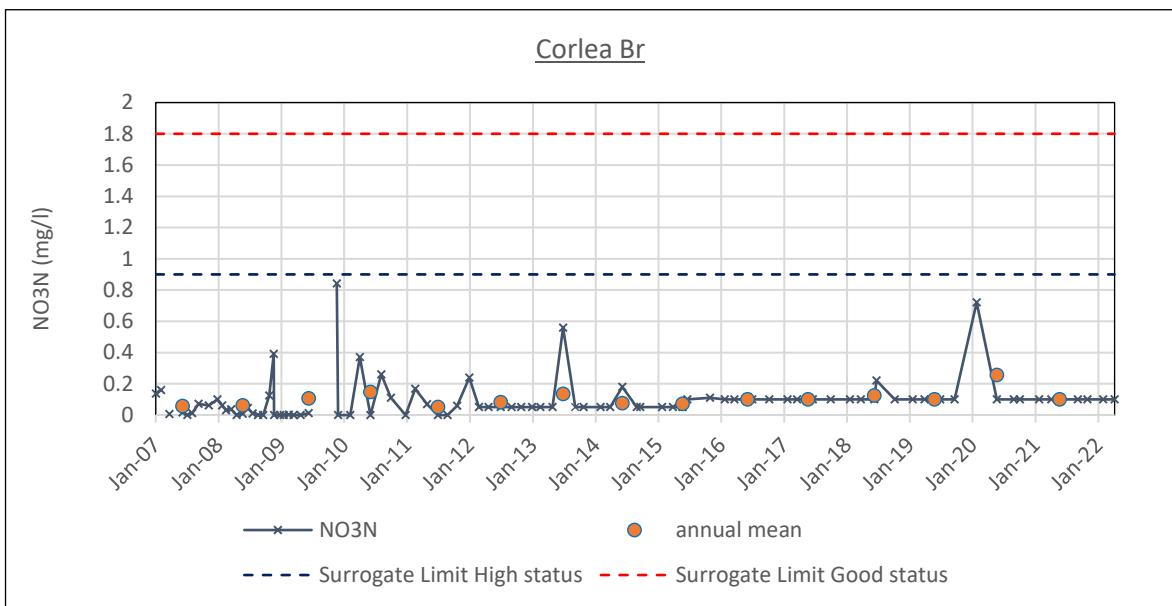
Figure 5 Nitrate nitrogen concentrations at Corlea Bridge from Jan 2007 to Feb 2022.

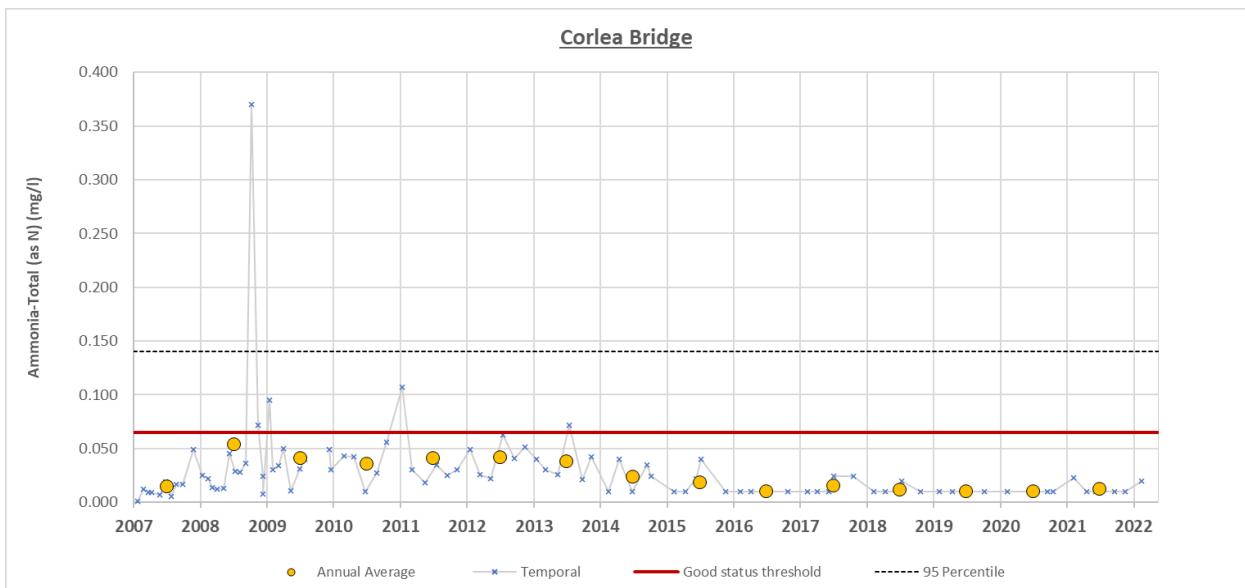
Figure 6 Total ammoniacal N concentrations at Corlea Bridge from Jan 2007 to Feb 2022

Annual average ammonium results at Corlea Bridge (**Figure 6**) were consistently below the mean Good status EQS of 0.065mg/l from 2007 to 2021. Temporally, individual sample results exceeded this mean limit on five occasions but the 95%ile limit was exceeded on one occasion only (0.37mg/l in October 2008).

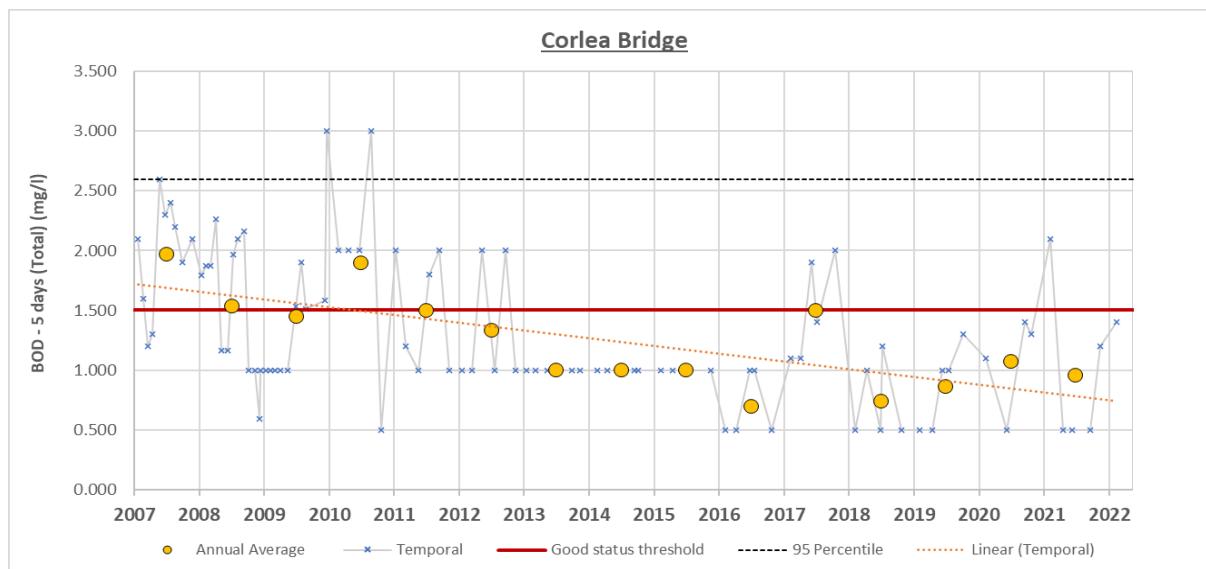
Figure 7 BOD levels at Corlea Bridge from Jan 2007 to Feb 2022

Annual average biochemical oxygen demand (BOD) results (**Figure 7**) have been at or below the mean Good status EQS of 1.5mg/l with the exception of results for 2007 and 2010. Results for 44% of individual samples collected between February 2007 and April 2022 exceeded this mean limit (i.e. 22 out of 50 sampling events). However all but three of these results were for samples collected prior to 2013.

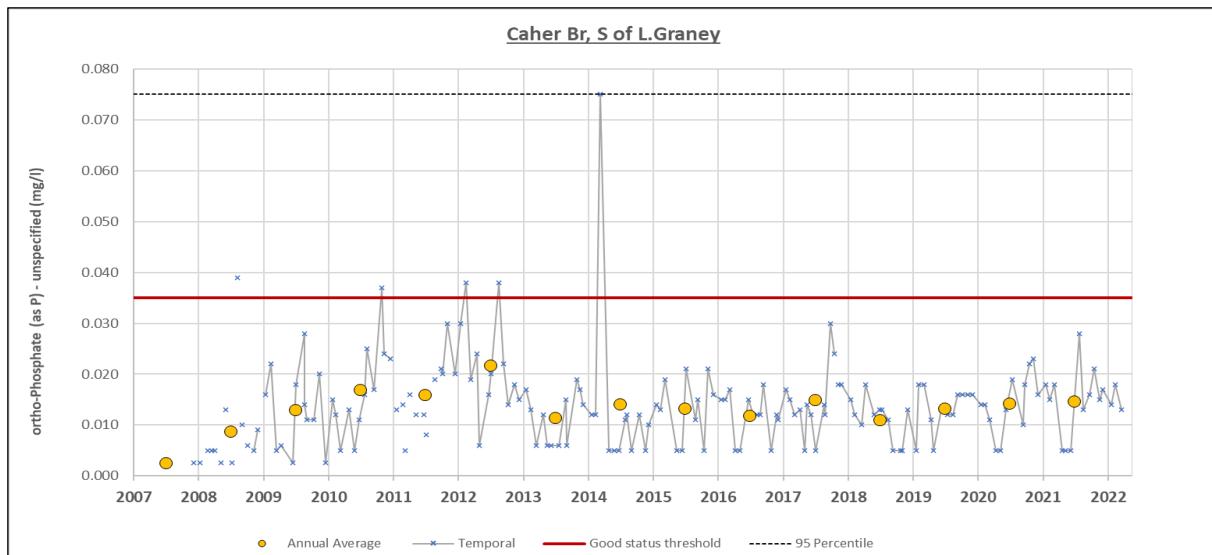
Figure 8 Orthophosphate concentrations at Caher Br, S of L. Graney from Jan 2007 to Feb 2022.

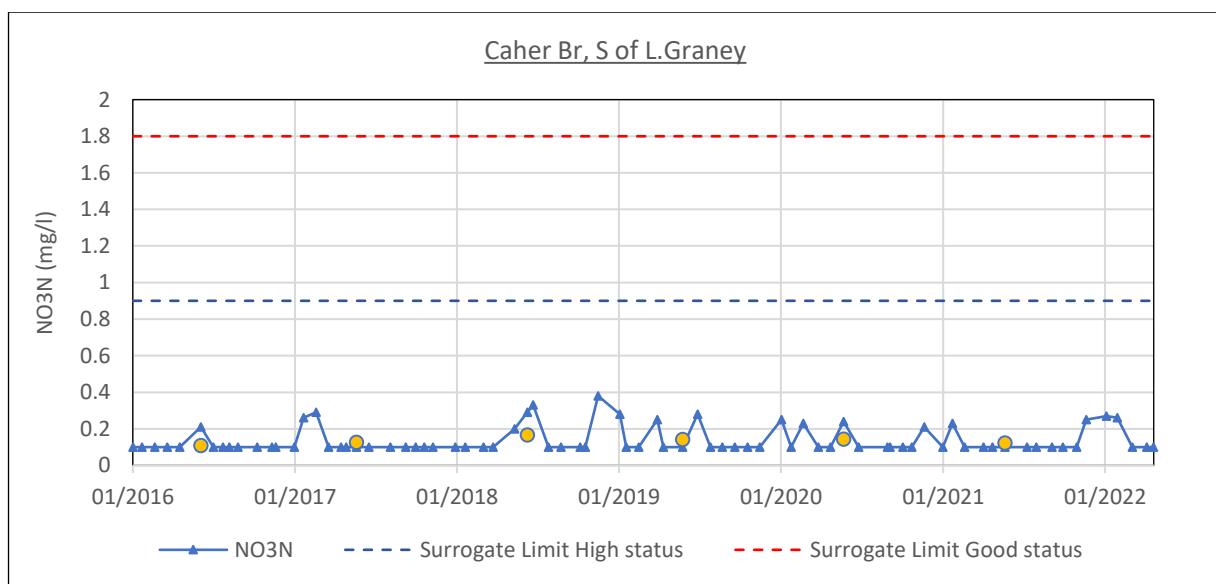
Figure 9 Total oxidised nitrogen concentrations at Caher Br, S of L. Graney from Jan 2007 to Feb 2022

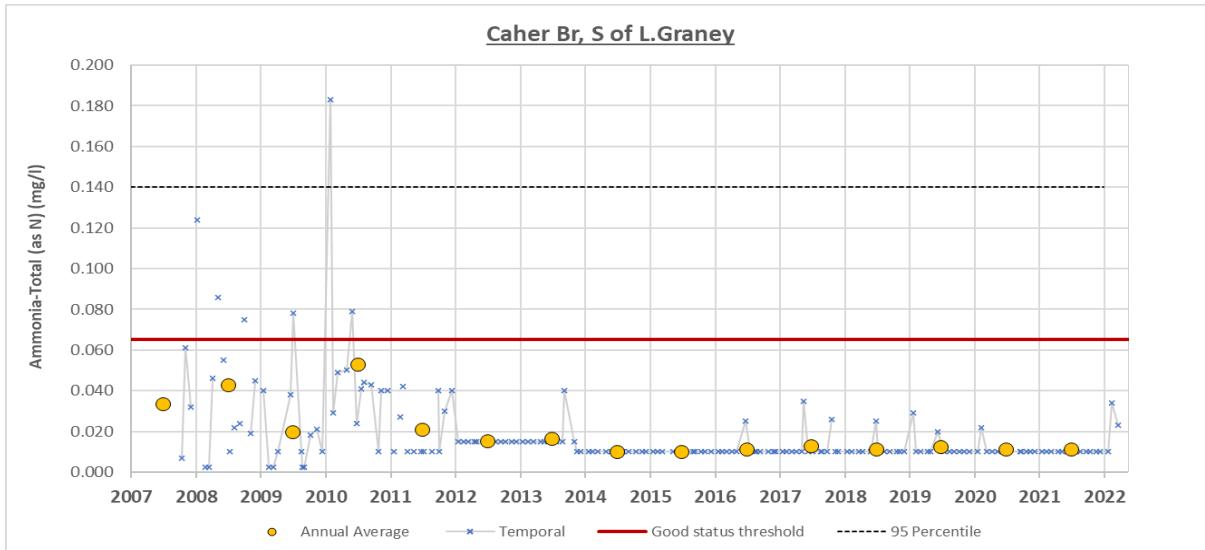
Figure 10 Total ammoniacal N concentrations at Caher Br, S of L. Graney from Jan 2007 to Feb 2022

Annual average ammonium results were below the mean Good status EQS every year from 2007 to 2021 inclusive (**Figure 10**). All individual sample results since June 2010 have been below the mean EQS. Results for six samples prior to June 2010 were above the mean EQS and one result in January 2010 exceeded the 95%ile limit of 0.14mg/l.

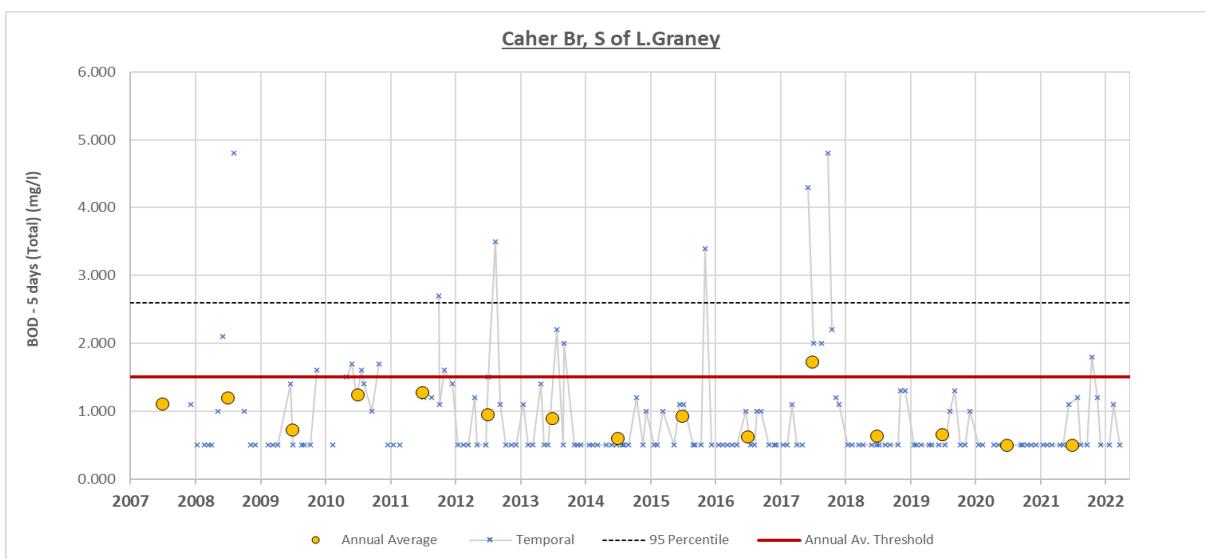
Figure 11 BOD results at Caher Br, S of L. Graney from Jan 2007 to Feb 2022

Annual mean BOD results were below the EQS except for 2017. Temporally, 12% of individual results were above the mean EQS. The Good status 95%ile limit of 2.6mg/l was breached on six occasions (**Figure 11**). For two of those sampling events, orthophosphate levels were also slightly elevated above the mean EQS of 0.035mg/l but levels of other nutrients were not elevated and dissolved oxygen levels were satisfactory.

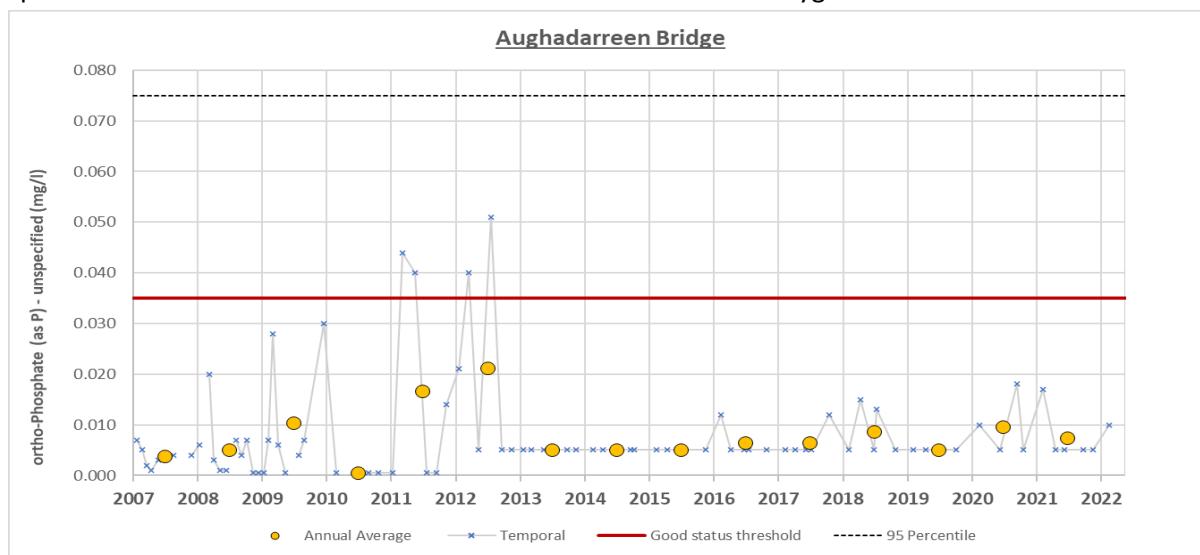
Figure 12 Orthophosphate concentrations at Aughadarreen Bridge from Jan 2007 to Feb 2022.

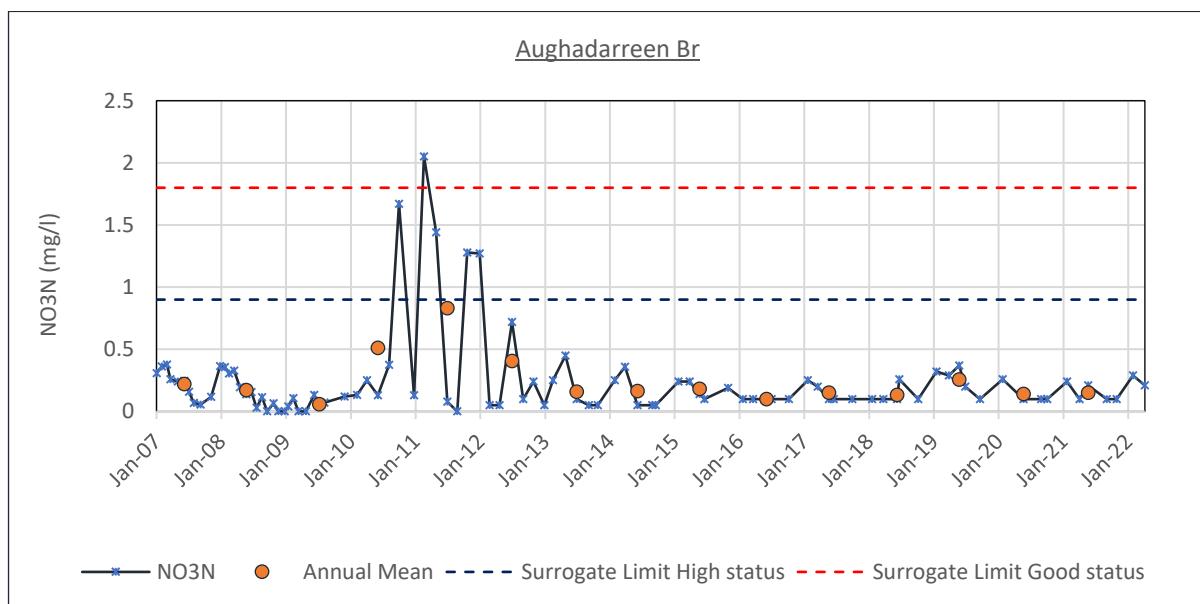
Figure 13 Nitrate concentrations at Aughadarreen Bridge from Jan 2007 to Feb 2022.

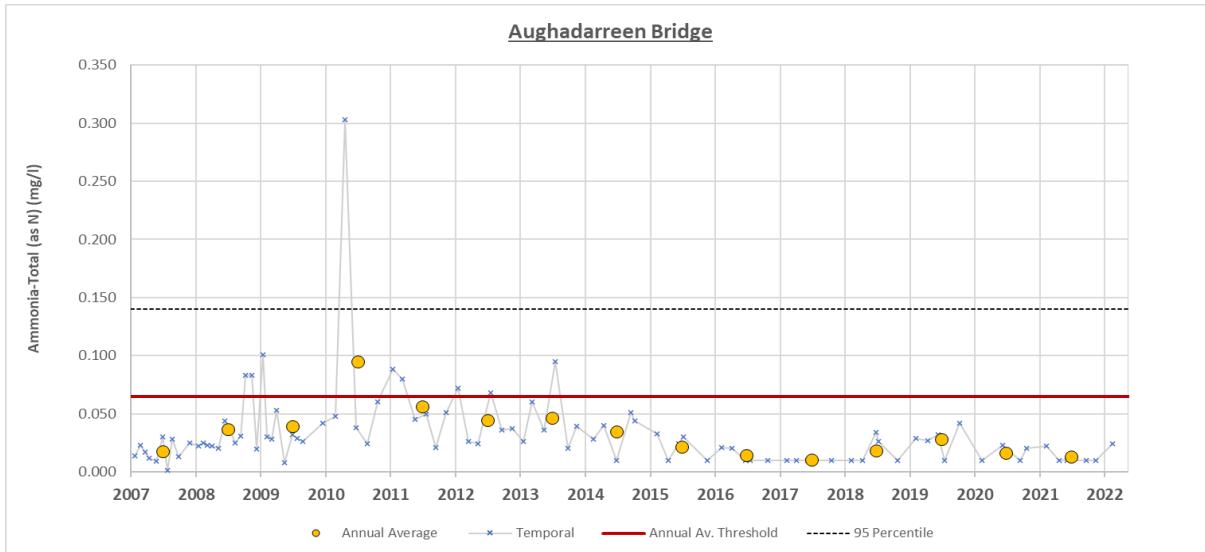
Figure 14 Total ammoniacal N concentrations at Aughadarreen Bridge from Jan 2007 to Feb 2022.

Annual average ammonium results have been below the mean EQS of 0.065mg/l except for 2010 (mean result of 0.095mg/l) (**Figure 14**). Individual results exceeded the 95%ile limit (0.14mg/l) on one occasion (0.3mg/l in April 2010).

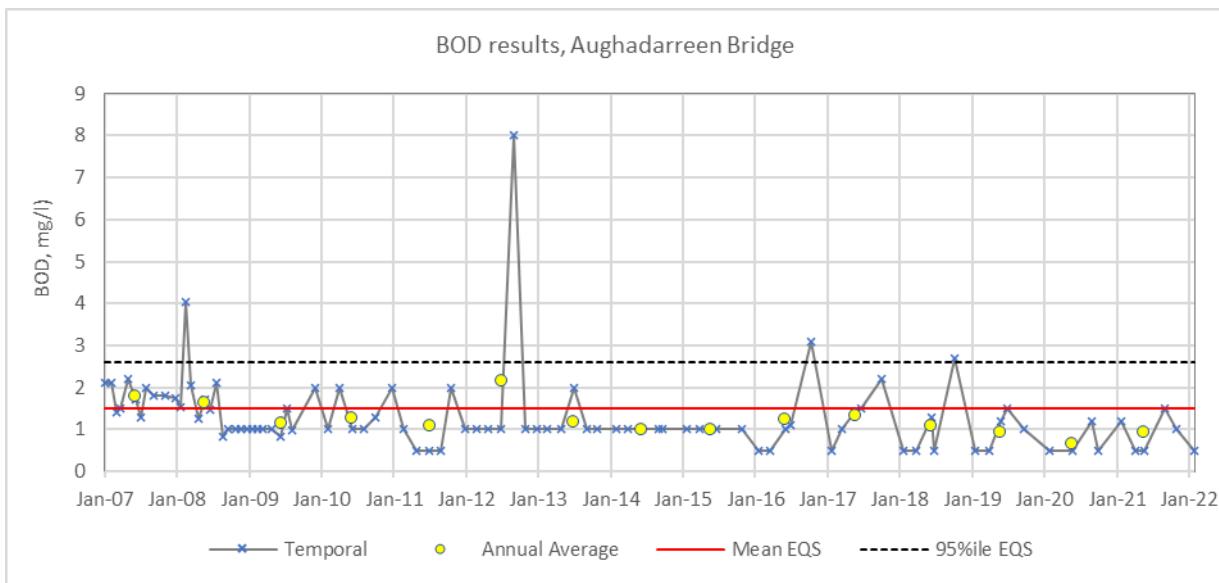
Figure 15 BOD levels at Aughadarreen Bridge from Jan 2007 to Feb 2022

Annual average BOD results exceeded the mean EQS of 1.5mg/l in 2007, 2008 and 2012. Annual means from 2013 to 2021 inclusive were within this limit but there have been spikes in individual results observed on occasion, including a significant spike of 8mg/l in September 2012 (**Figure 15**). These BOD spikes did not coincide with elevated nutrients or low dissolved oxygen levels.

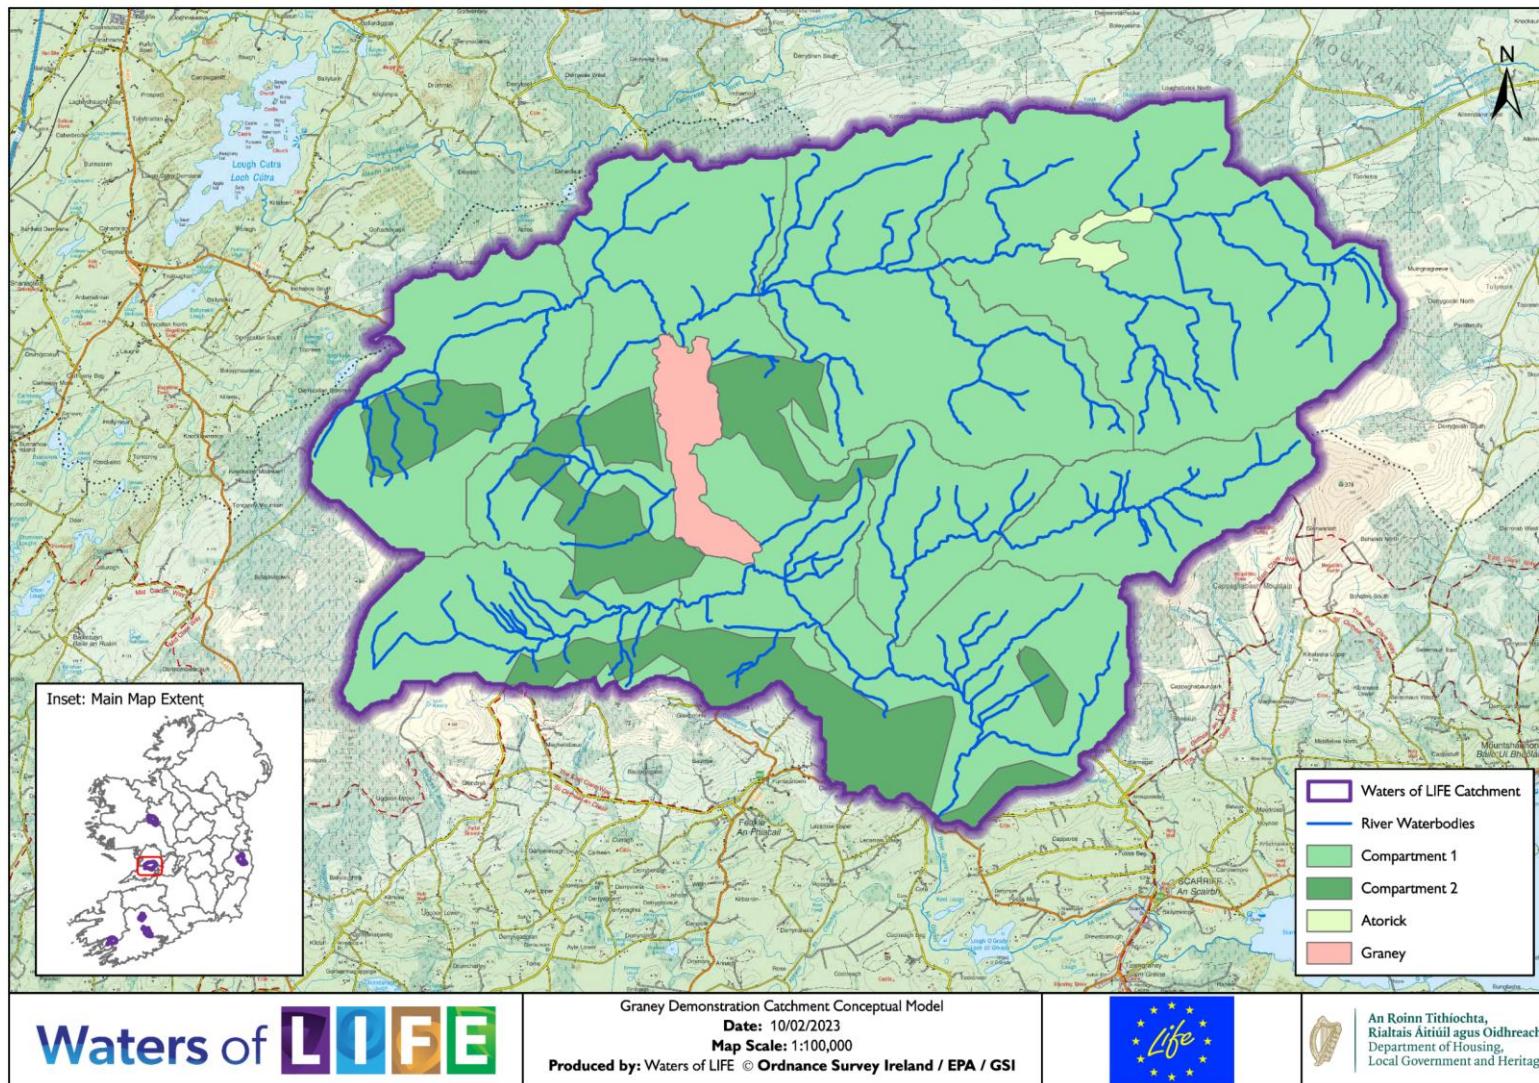
Figure 16 Conceptual model illustrating the compartments

Compartment 1 (C1)	Compartment 2 (C2)
Bedrock unit	Devonian Old Red Sandstone (~66%), Silurian Metasediments and Volcanics (~35%), Ordovician Volcanics (<1%), Dinantian Lower Impure Bedded Limestone (<1%)	Silurian Metasediments and Volcanics (~85%), Devonian Old Red Sandstone (~10%), Ordovician Volcanics (~5%)
Aquifer	Generally Unproductive except for Local Zones (Pl)	
Aquifer properties	GWB is comprised of generally low transmissivity and storativity rocks. i.e., Silurian and Devonian. Flows in the aquifer are typically concentrated in a thin zone at the top of the rock. Recharge occurs particularly in the upland areas, and where rock outcrops, or subsoils are thin. Locally, groundwater flows to the surface water bodies and is determined by local topography.	
Topography	Undulating to hill in Bleach sub-basin, Lough Graney and Graney mainchannel, hill to mountain elsewhere	Undulating to hill/hill to mountain

Soil	Peat, Poorly drained - Humic Surface-water Gleys (Gortaclareen Series) and Humic Groundwater Gleys (Puckane Series).	Well drained - Typical Brown Earths (Ballylanders Series)
Subsoil	BktPt (~65%), TDSs (~20%), Rck (~5%) TLPSsS (~10%), Alluvium (~1%)	Rck (~75%) TLPSsS (~25%)
Groundwater vulnerability	High to X-Extreme in west and south and east of Lough Graney, moderate to low in North-East	High to X-Extreme, shallow soils/sub-soils and rock outcrops
PO ₄ ⁺ susceptibility	High (risk ranked as 2-4)	Very high (risk rank 1) localised, risk rank 2-3 along the mainchannel
PO ₄ ⁺ Flowpaths	Overland flow and near surface	Overland flow and near surface
NO ₃ susceptibility	Low	High to very high (risk ranked 1-4). Very high risk around Lough Graney and to the west of the catchment
NO ₃ flowpaths	Near surface	Near surface

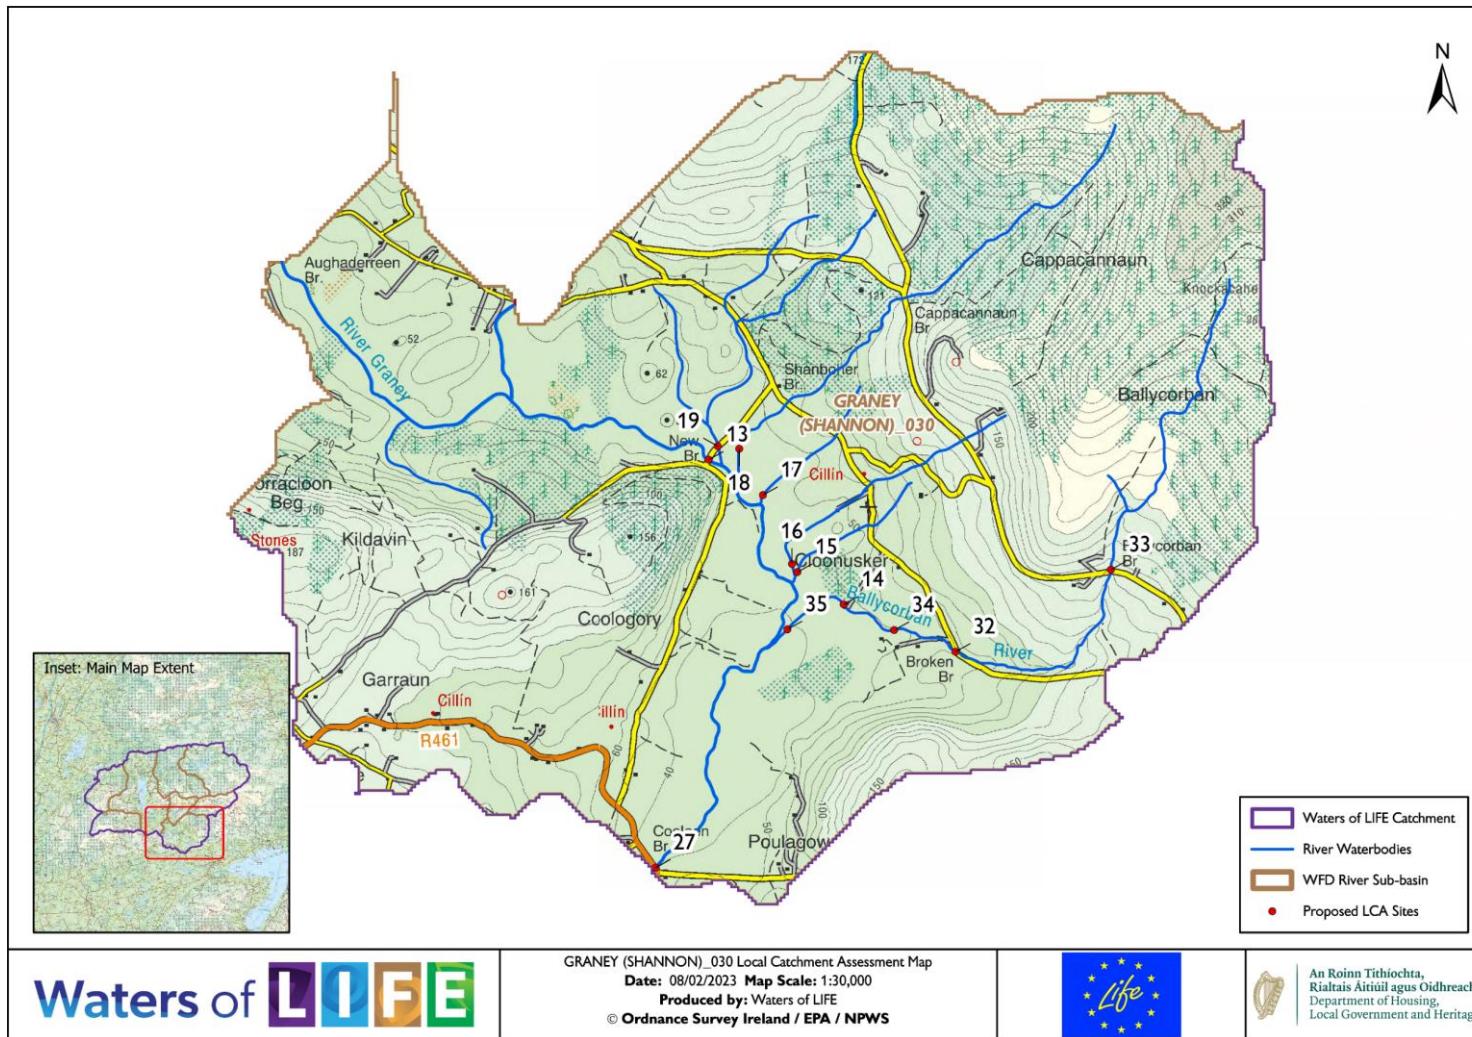
Figure 24 LCA sites in Graney(Shannon)_030

This Blue Dot waterbody requires restoration. It is at Good ecological status (2013-2018) and *At Risk*. Initial LCA sites are shown in Figure 24. Sites should be assessed as outlined in I to iv above. Sediment is a likely significant issue at the WFD monitoring station so LCA should involve sediment assessment across the sub-basin. As for other waterbodies in the catchment, sediment sources should be identified to aid in planning for mitigation measures. If nutrient monitoring results are inconclusive but LCA indicates that nutrients may be an issue, higher resolution sampling may be needed at the WFD monitoring point in case of periodic nutrient spikes.
