Graney Demonstration Catchment

Desk Study

October 2022

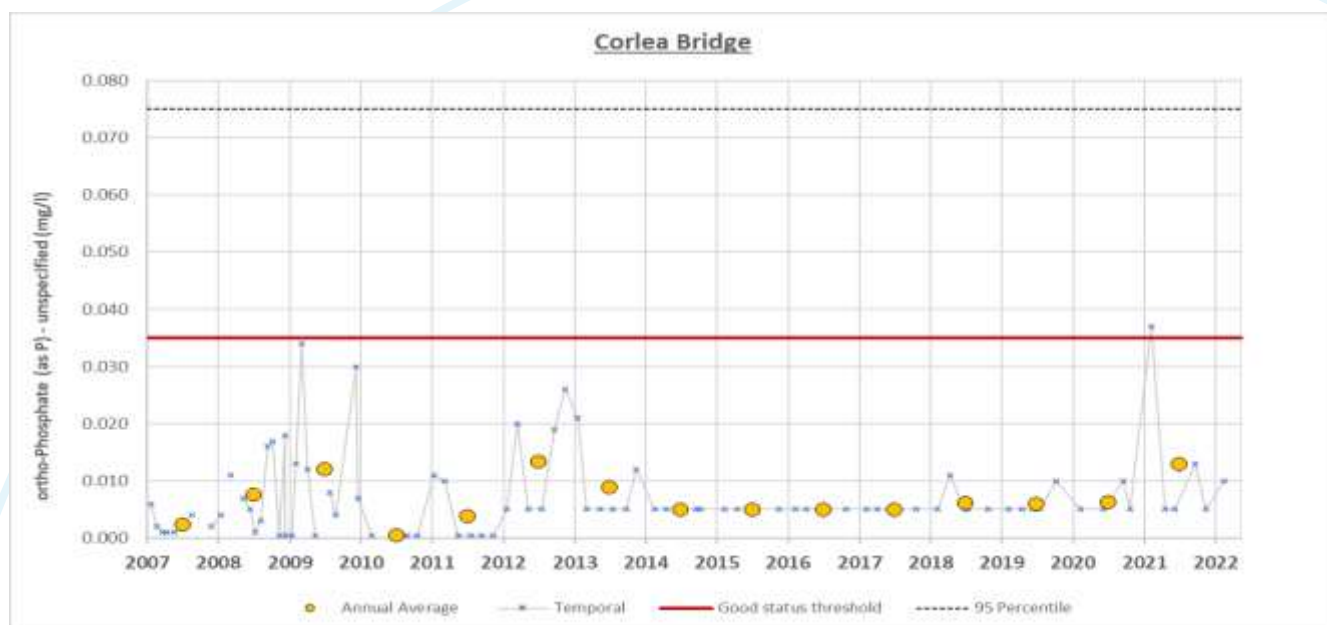
Figure 4 Orthophosphate concentrations at Corlea Bridge from Jan 2007 to Feb 2022

From WFD chemistry monitoring data available for Corlea Bridge, nutrients do not appear to be a cause for concern in Bleach_010. Annual average orthophosphate results were well below the mean Good status EQS of 0.035mg/l from 2007 to 2021 inclusive (**Figure 4**). Individual sample results were also consistently below the mean EQS within the exception of one result in February 2021 which marginally exceeded 0.035mg/l but was significantly below the 95%ile limit of 0.075mg/l. 85% of individual sample results between February 2014 and April 2022 have been below the orthophosphate detection limit of 0.01mg/l.

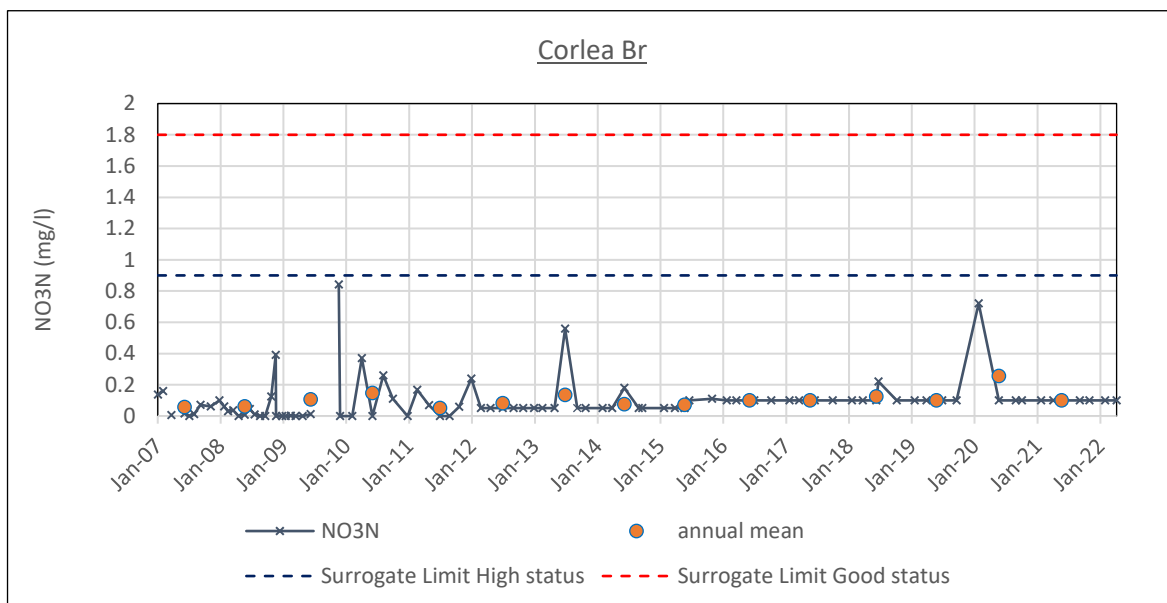
Figure 5 Nitrate nitrogen concentrations at Corlea Bridge from Jan 2007 to Feb 2022.

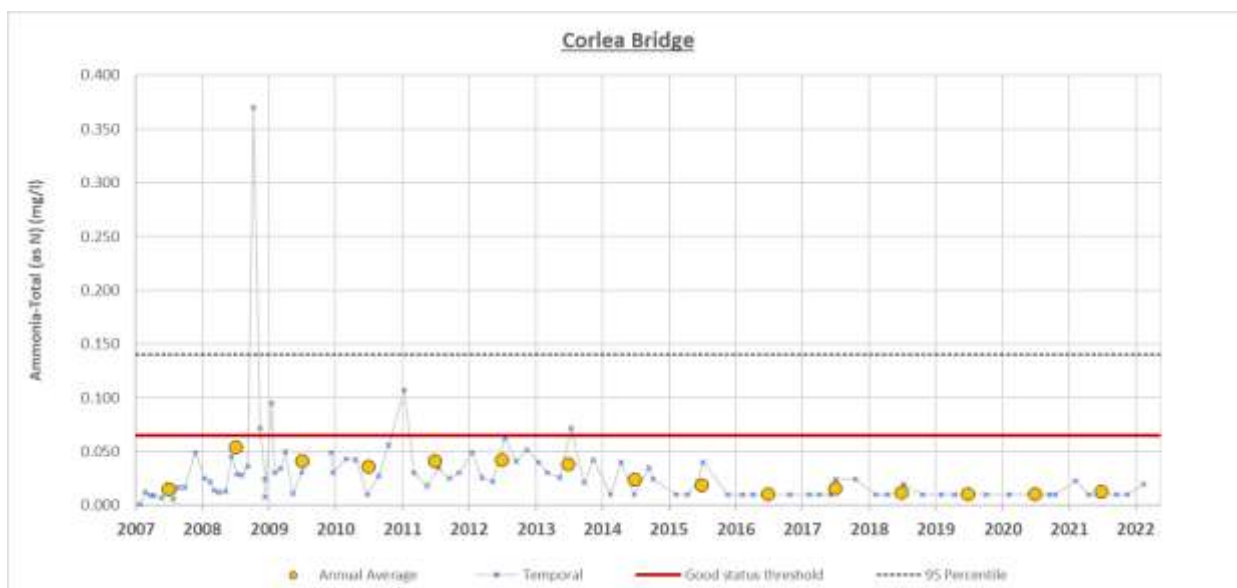
Figure 6 Total ammoniacal N concentrations at Corlea Bridge from Jan 2007 to Feb 2022

Annual average ammonium results at Corlea Bridge (**Figure 6**) were consistently below the mean Good status EQS of 0.065mg/l from 2007 to 2021. Temporally, individual sample results exceeded this mean limit on five occasions but the 95%ile limit was exceeded on one occasion only (0.37mg/l in October 2008).

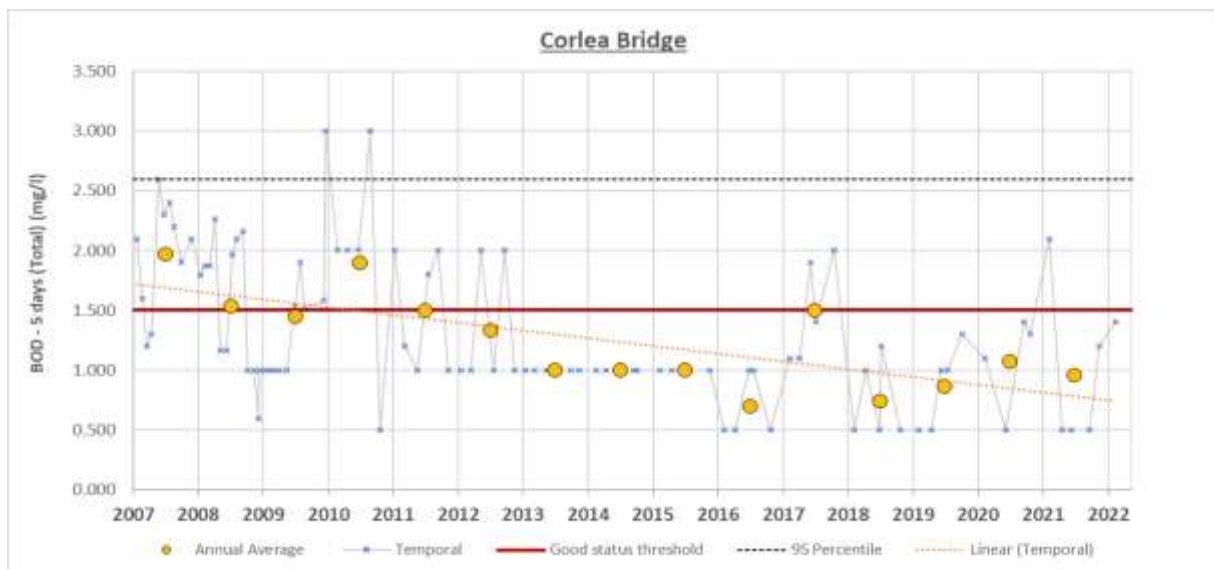
Figure 7 BOD levels at Corlea Bridge from Jan 2007 to Feb 2022

Annual average biochemical oxygen demand (BOD) results (**Figure 7**) have been at or below the mean Good status EQS of 1.5mg/l with the exception of results for 2007 and 2010. Results for 44% of individual samples collected between February 2007 and April 2022 exceeded this mean limit (i.e. 22 out of 50 sampling events). However all but three of these results were for samples collected prior to 2013.

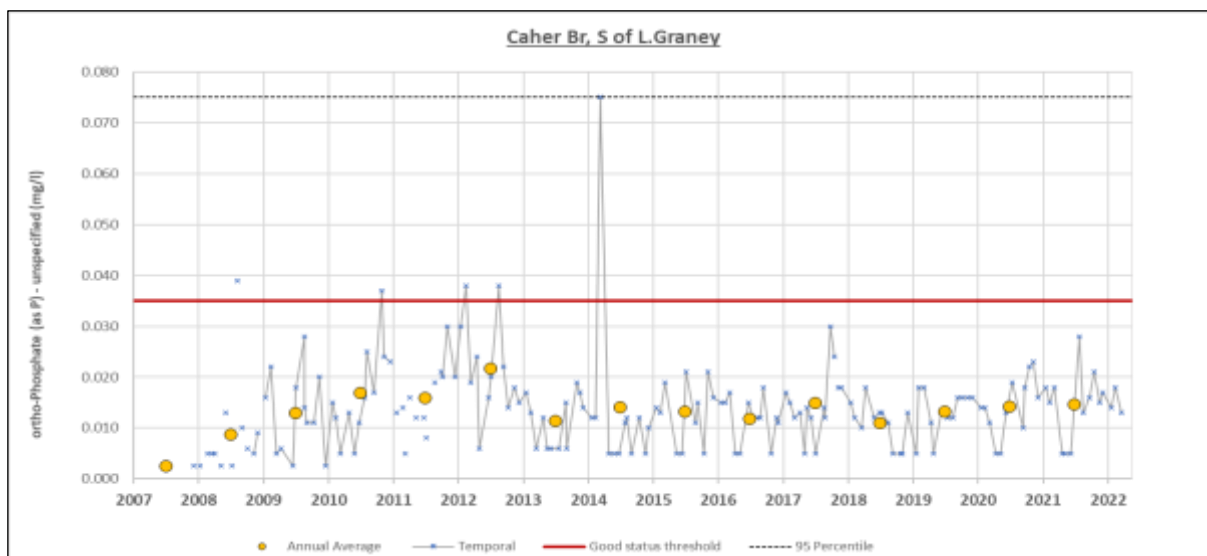
Figure 8 Orthophosphate concentrations at Caher Br, S of L. Graney from Jan 2007 to Feb 2022.

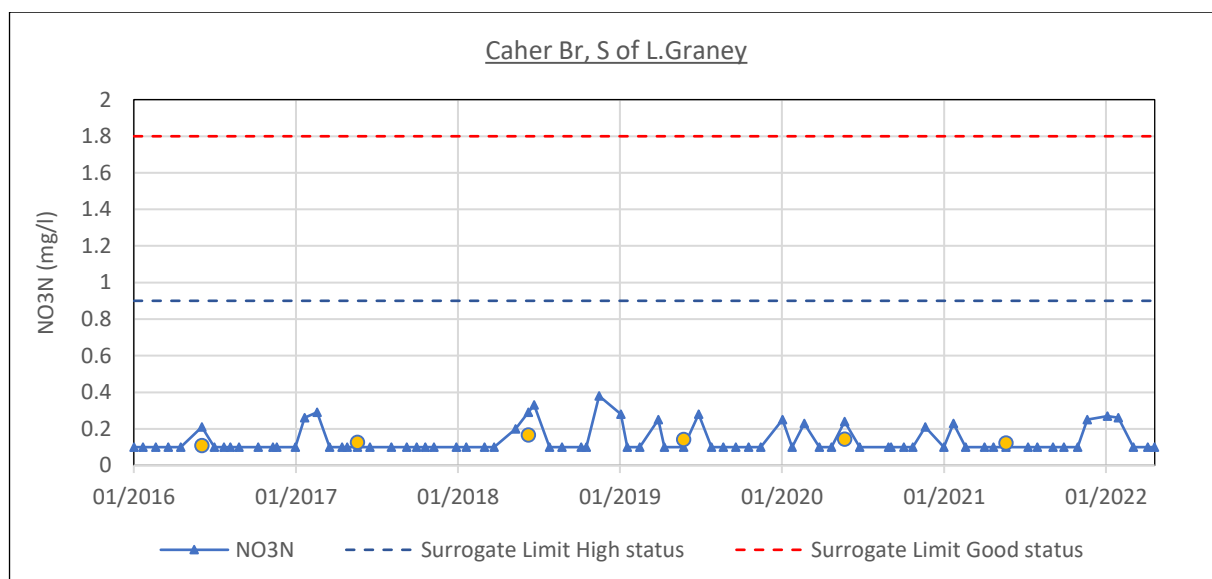
Figure 9 Total oxidised nitrogen concentrations at Caher Br, S of L. Graney from Jan 2007 to Feb 2022

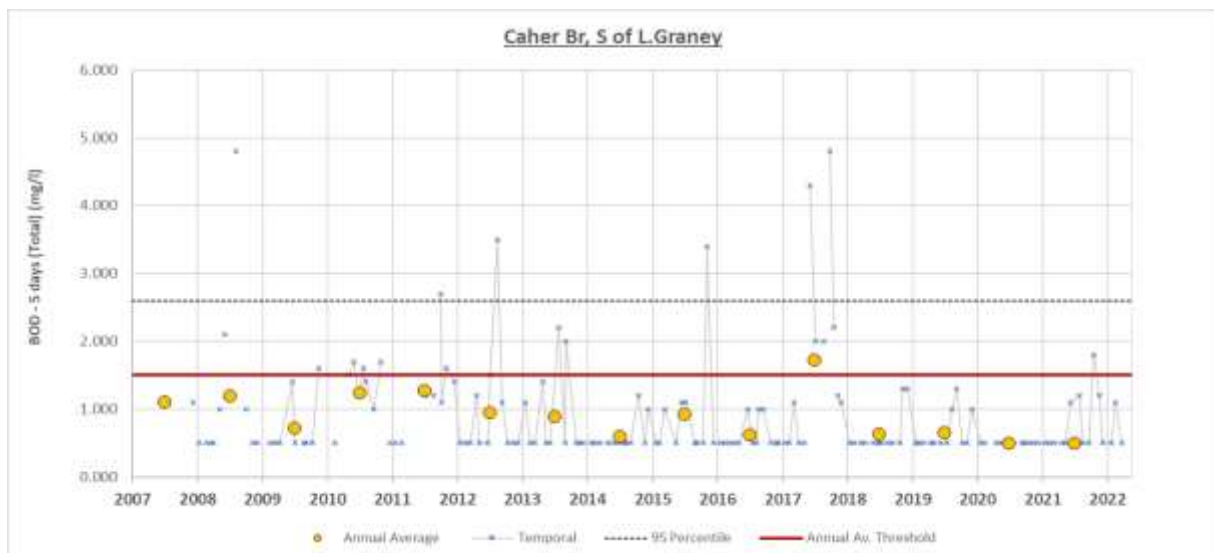
Figure 11 BOD results at Caher Br, S of L. Graney from Jan 2007 to Feb 2022

Annual mean BOD results were below the EQS except for 2017. Temporally, 12% of individual results were above the mean EQS. The Good status 95%ile limit of 2.6mg/l was breached on six occasions (**Figure 11**). For two of those sampling events, orthophosphate levels were also slightly elevated above the mean EQS of 0.035mg/l but levels of other nutrients were not elevated and dissolved oxygen levels were satisfactory.

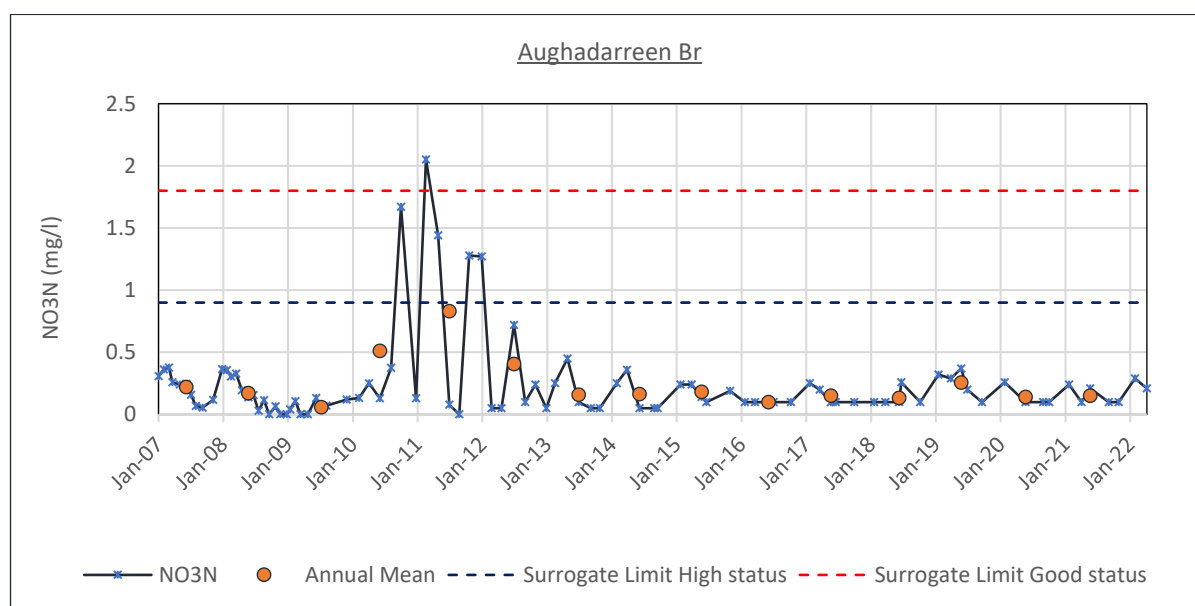
Figure 13 Nitrate concentrations at Aughadarreen Bridge from Jan 2007 to Feb 2022.

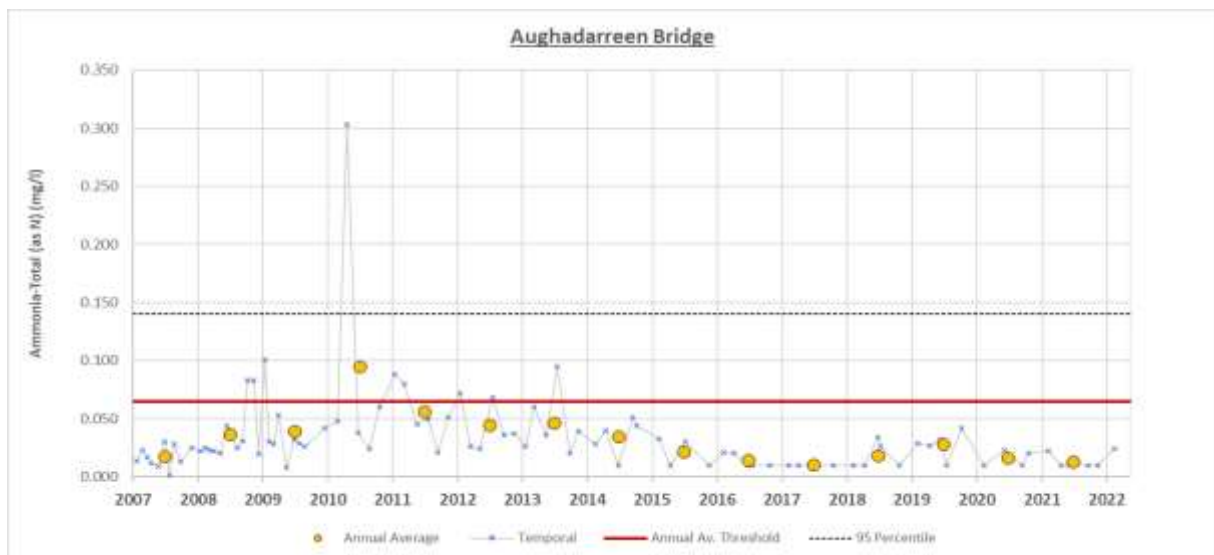
Figure 14 Total ammoniacal N concentrations at Aughadarreen Bridge from Jan 2007 to Feb 2022.

Annual average ammonium results have been below the mean EQS of 0.065mg/l except for 2010 (mean result of 0.095mg/l) (**Figure 14**). Individual results exceeded the 95%ile limit (0.14mg/l) on one occasion (0.3mg/l in April 2010).

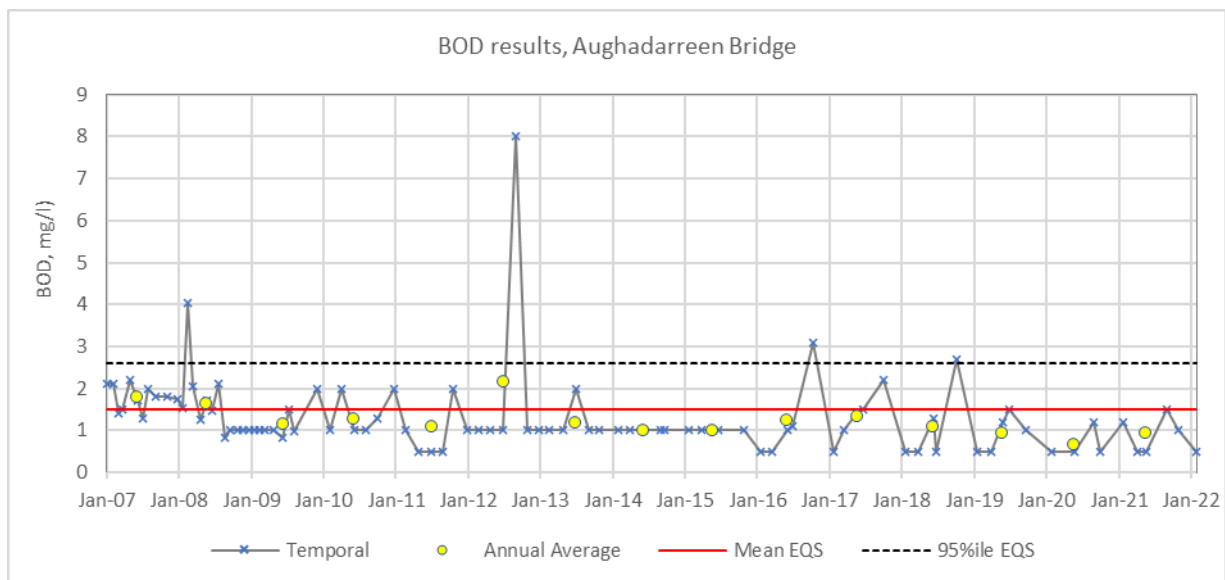
Figure 15 BOD levels at Aughadarreen Bridge from Jan 2007 to Feb 2022

Annual average BOD results exceeded the mean EQS of 1.5mg/l in 2007, 2008 and 2012. Annual means from 2013 to 2021 inclusive were within this limit but there have been spikes in individual results observed on occasion, including a significant spike of 8mg/l in September 2012 (**Figure 15**). These BOD spikes did not coincide with elevated nutrients or low dissolved oxygen levels.
